# BRIDGE INSPECTION REPORT

Agency Snohomish County

| Bridge Name PORTAGE CREEK #247 | | Printed On 09/18/2006 | |
| Structure ID 08226400 | Route 96855 | Intersecting | PORTAGE CREEK |

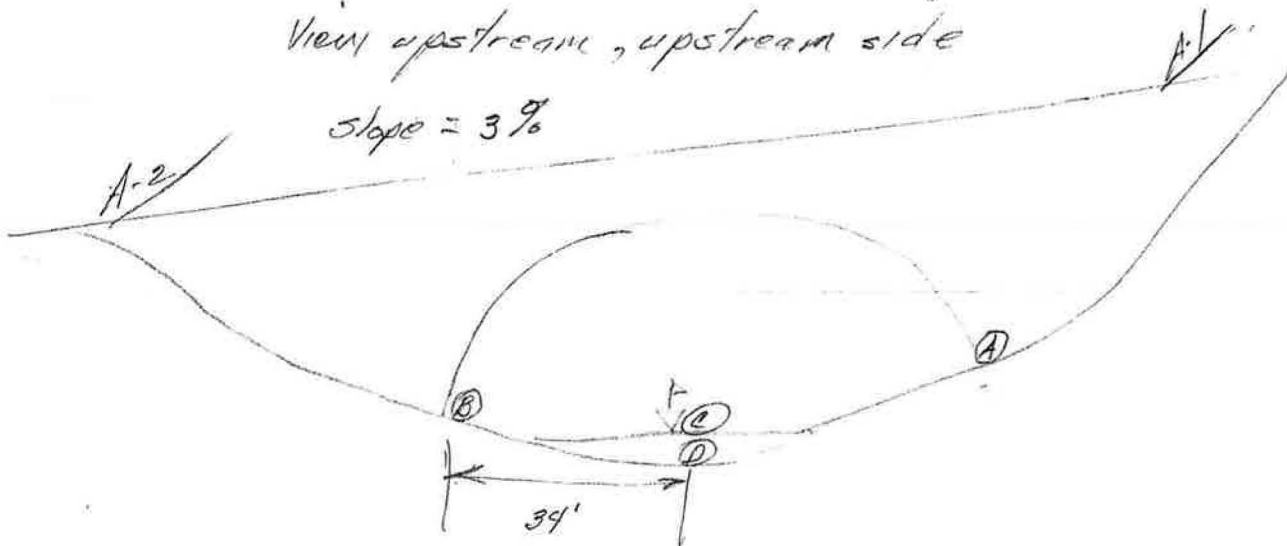
View upstream, upstream side

slope = 3%

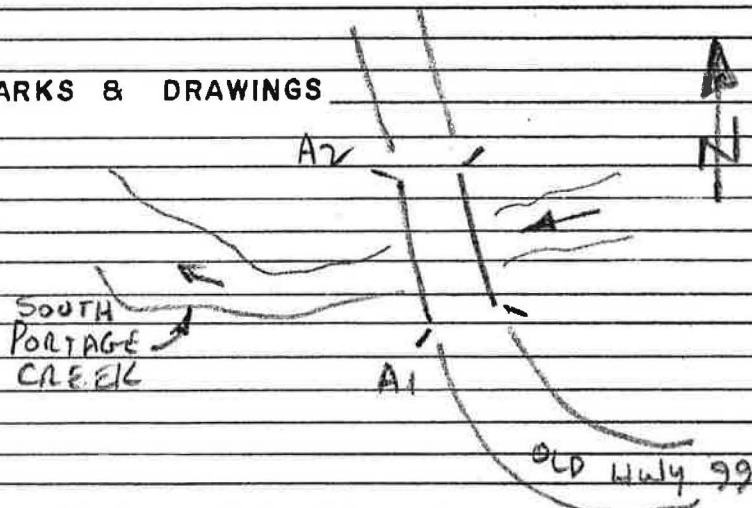
REMARKS & DRAWINGS

1. ARCHES Good To Fair - PCC - Longitudinal & Random Cracking w/ MINOR EFFLORESCENCE - ONE CRACK @ BASE OF ARCH ON SOUTH END IS SEEPING WATER STEADILY (ESTIMATE 1 G.P.M. ±)
2. CAPS N/A
3. PIERS N/A
4. INTERMEDIATE BENTS None
  - a. piles N/A

RECOMMENDED REPAIRS CLEAN DECK OF SAND, UPGRADE GUARDRAIL TRANSITIONS
