# BRIDGE INSPECTION REPORT

Agency: Snohomish County

Bridge No.	91	Page 1 of 2	Structure Type
Bridge Name	SOUTH SLOUGH #91	Route	96855 Intersecting SOUTH SLOUGH
Structure ID	08084500	MilePost	9.40 Location .3 S JCT SR 530

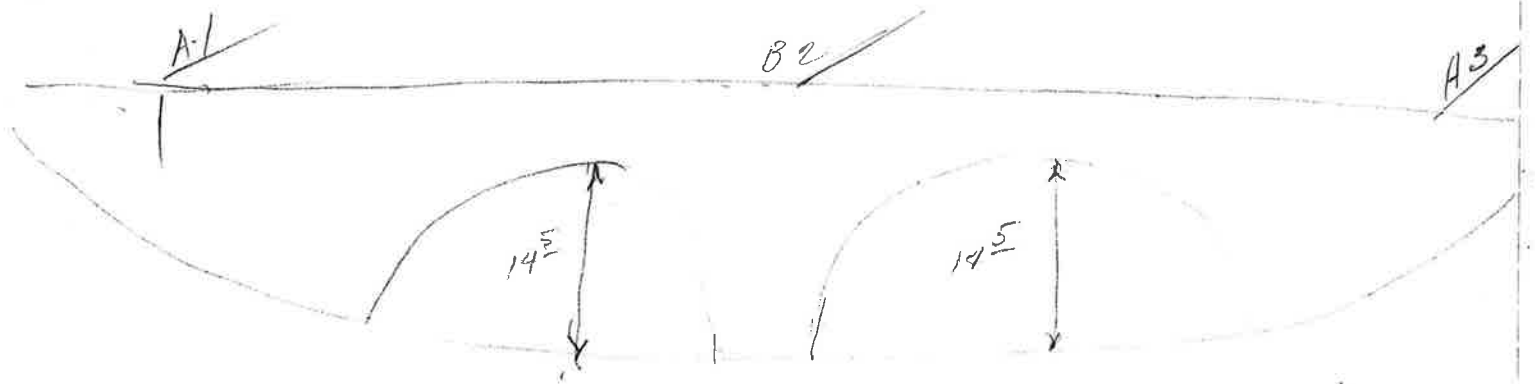
Dr. 71  
Downstream side, view down from

Channel is nearly level in x-section

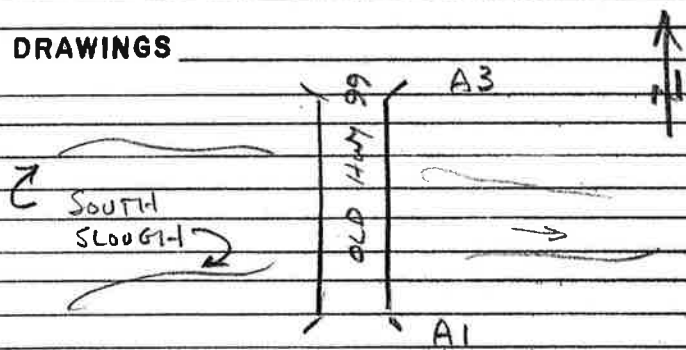
- 1. ARCHES FAIR TO POOR - MAJOR SPALLING EXPOSED REBAR, CRACKING  
W/ EFFLORESCENCE @ SOFFIT AREA (LONGITUDINAL & RANDOM)
- 2. CAPS N/A
- 3. PIERS N/A
- 4. INTERMEDIATE BENTS N/A
- a. piles N/A

ABUTMENTS & BULKHEADS Poor - SETTLEMENT CRACKING, EXPOSED REBAR MAJOR SPALLS

RECOMMENDED REPAIRS BOTH GUARDRAIL TRANSITIONS SHOULD BE UPGRADED - DECK & RAILING SHOULD BE REHABILITATED SIMILAR TO BR-247 (WIDEN TO CURRENT STANDARDS & ADD JERSEY BARRIERS)

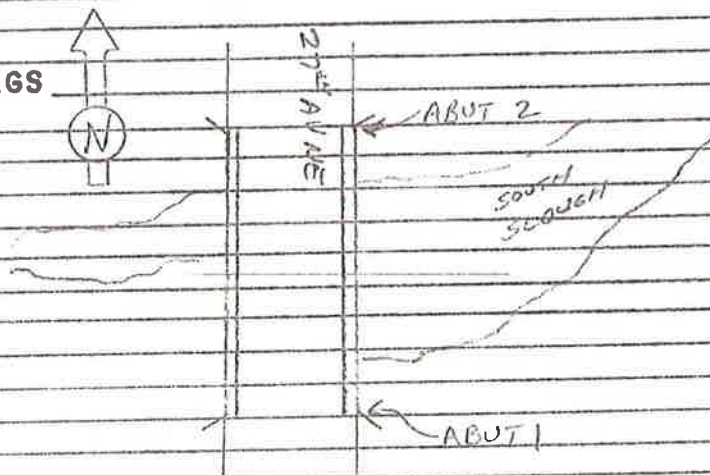
1. ARCHES POOR - PCC SOFFITS @ ARCHES HAVE MAJOR SPALLS, EXPOSED RE-STEEL,  
DIFFERENTIAL SETTLEMENT CRACKS / GROUND WATER & EFFLUORESCENCE EXFILTRATING  
FROM WITHIN STRUCTURE

ABUTMENTS & BULKHEADS POOR - PCC WING WALLS HAVE DEFICIENCIES LISTED  
MAJOR SPALLING & SCALING, EXPOSED RE-STEEL, SETTLEMENT CRACKS

RECOMMENDED REPAIRS MAJOR PATCHWORK @ DEFICIENT LISTED ITEMS, SEAL  
EXPANSION JOINTS & SETTLEMENT CRACKS

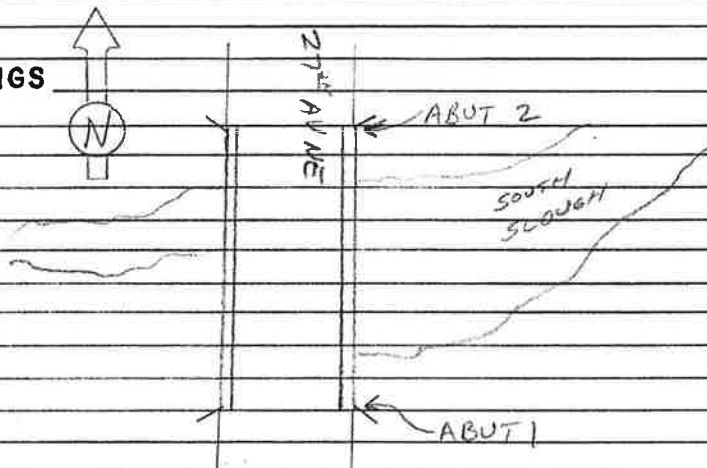
1. ARCHES POOR - PCC SOFFITS & ARCHES HAVE MAJOR SPALLS EXPOSED RE-STEEL,  
DIFFERENTIAL SETTLEMENT CRACKS "/>GROUND WATER & EFFLORESCENCE INFILTRATING  
FROM WITHIN STRUCTURE

ABUTMENTS & BULKHEADS POOR - PCC WING WALLS HAVE DEFICIENCIES LISTED  
MAJOR SPALLING, SCALING, EXPOSED RE-STEEL, SETTLEMENT CRACKS

RECOMMENDED REPAIRS MAJOR PATCHWORK @ DEFICIENT LISTED ITEMS, SEAL  
EXPANSION JOINTS & SETTLEMENT CRACKS

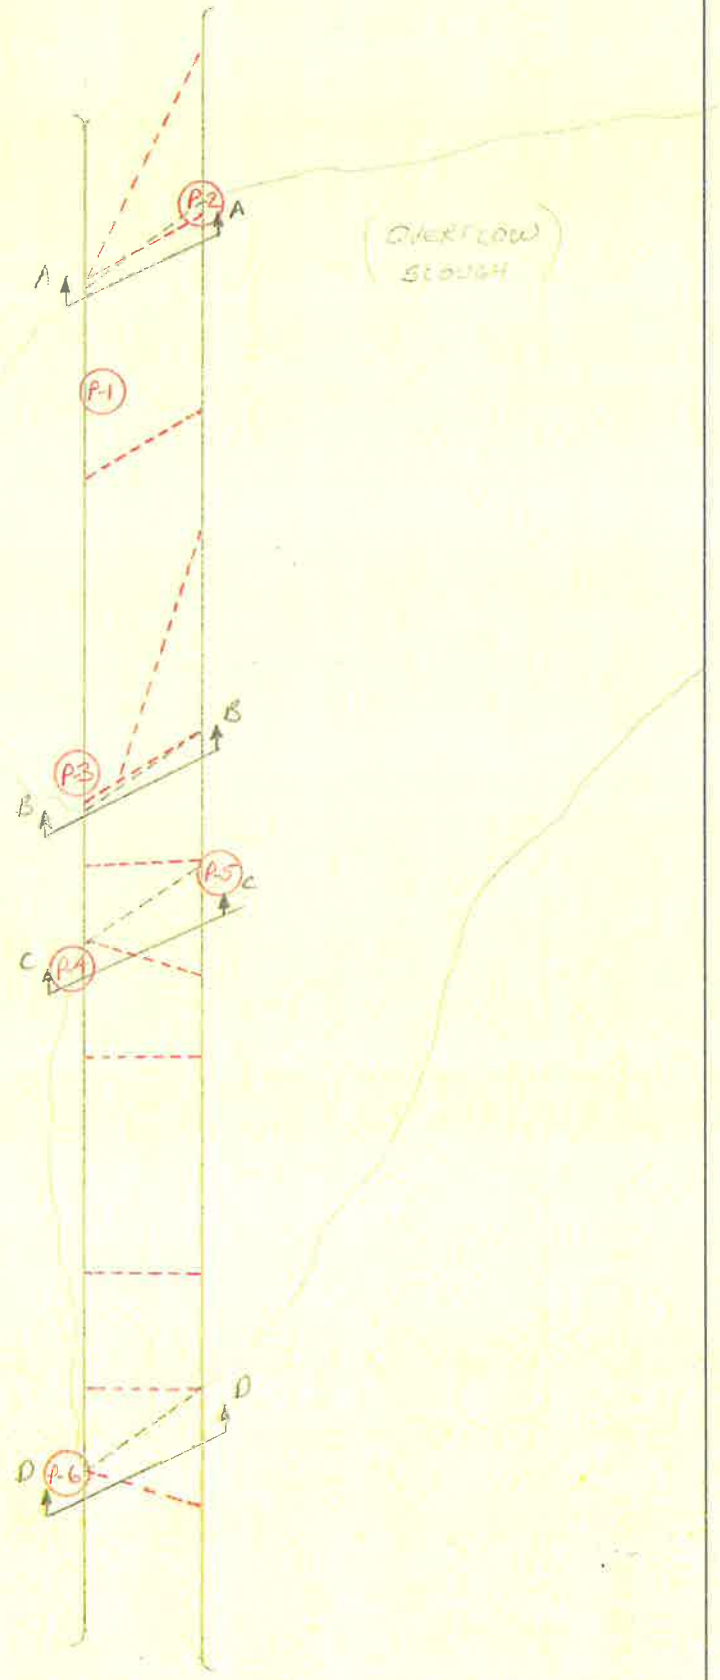
NOTE RED LINES  
DENOTE AC PAVT CRACKS

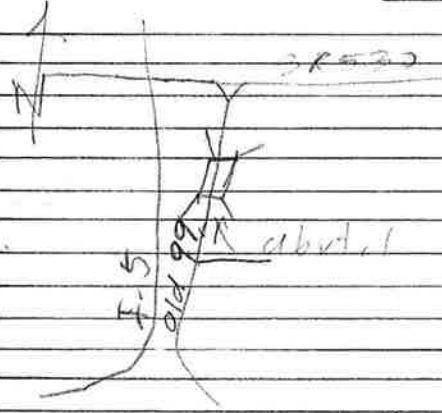
4. RAILS concrete rails are having minor cracking under the top portion of rails. Pictures showing a vertical line at center on top side

RECOMMENDED REPAIRS Repair rail top.

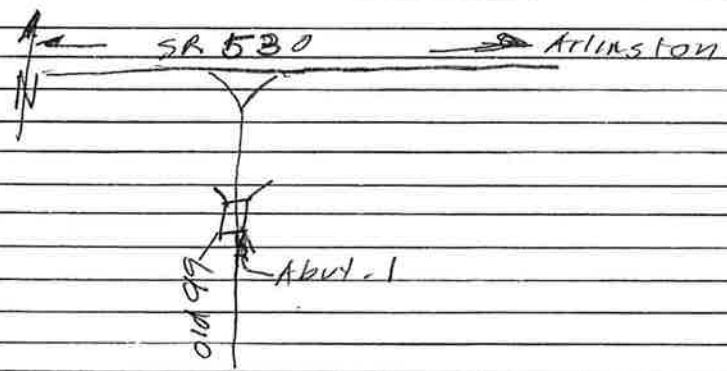
4. RAILS 3ft concrete rails have spalling and cracks underneath top cap of rail,

1. ARCHES Both arches are in good condition, Arch from center to Abut-3 is twisting to the east about 1/4 of an inch
