**To:** James Yap, Snohomish County Parks and Recreation  
**From:** Debra Overbay, PE and Jon Ambrose, GeoEngineers  
**Date:** December 29, 2010  
**File:** 3734-008-03  
**Subject:** Technical Memorandum  
Centennial Trail Phase 2B, Pilchuck Creek Embankment Repair and Haller Trestle Pier 4

This memorandum presents a summary of our additional explorations and analyses completed in support of the Pilchuck Embankment Repair and protection of Haller Trestle Pier 4 as part of the Centennial Trail Phase 2B project. Geotechnical engineering recommendations for repair to the Pilchuck Creek Bridge Pier 2 repairs were provided in our previous report dated February 4, 2010, "Pilchuck Creek Bridge Crossing, Centennial Trail, Phase 2, Snohomish County, Washington".

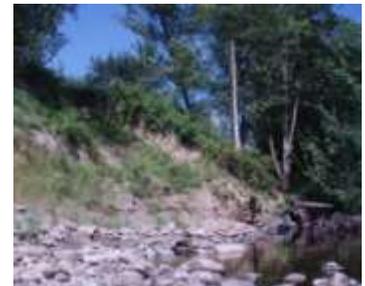
We completed a site reconnaissance of the lower slope and edge of the creek and observed weathered sandstone at approximately Elevation 112 to 114 feet (based on the survey contours provided by Pacific Survey & Engineering, Inc.). A coarser grained layer of bedrock was observed below the sandstone along the edge of the creek, roughly below Elevation 111 feet. We interpret this as a lense of conglomerate, consistent with the geologic mapping description of the McMurray Quadrangle. This material was also noted within the outcrop located at the north end of the failure zone at the edge of the creek.

North Edge of Pilchuck Creek Embankment Failure

We recommend a timber crib wall and engineered fill be constructed to restore the embankment failure between approximate stations 254+75 and 256+75. Design plans of the crib wall and rip-rap armor for the end treatment are shown in the drawings, Sheets CW1.1 through CW1.4 transmitted with the permit package. The anchored crib wall structure provides a stable toe along the embankment, as well as the recommended bioengineering features for the project. A summary of our analyses of the structure and upper slope, and construction considerations are presented below.

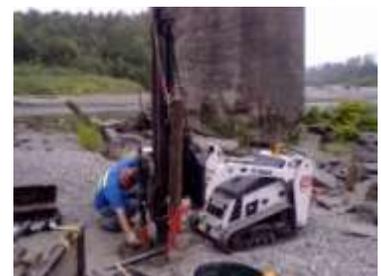
Drilling at Haller Trestle, Pier 4
