HYDRO TERRA, LLC

Application No.: City of Arlington PFN
Tax Account No.: 310527-002-001-00
Site Location: 5800 172nd Street, Arlington, WA.
Property Owner: 4-T Development, LLC
Legal Description: Lot 2 of Rev SP 82(74) REC AF No. 8304280231. Situated in a portion of the E1/2, of the NE1/4, of the NW1/4 of T31N, R05E, S27, W.M., Snohomish County, WA.

Subject: Critical Area Study, Mitigation Plan and Habitat Management Plan

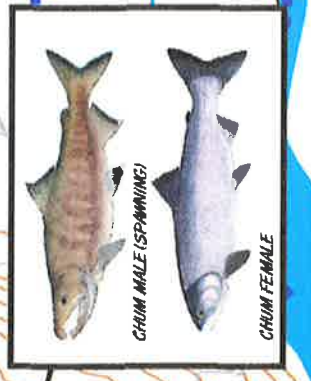
Chum Distribution

- Chum Spawning (Red dots)
- Chum Presence (Blue dots)
- Chum Rearing (Yellow dots)
- 10 meter contours (Orange lines)
- Quilceda/Allen Watershed (Black outline)

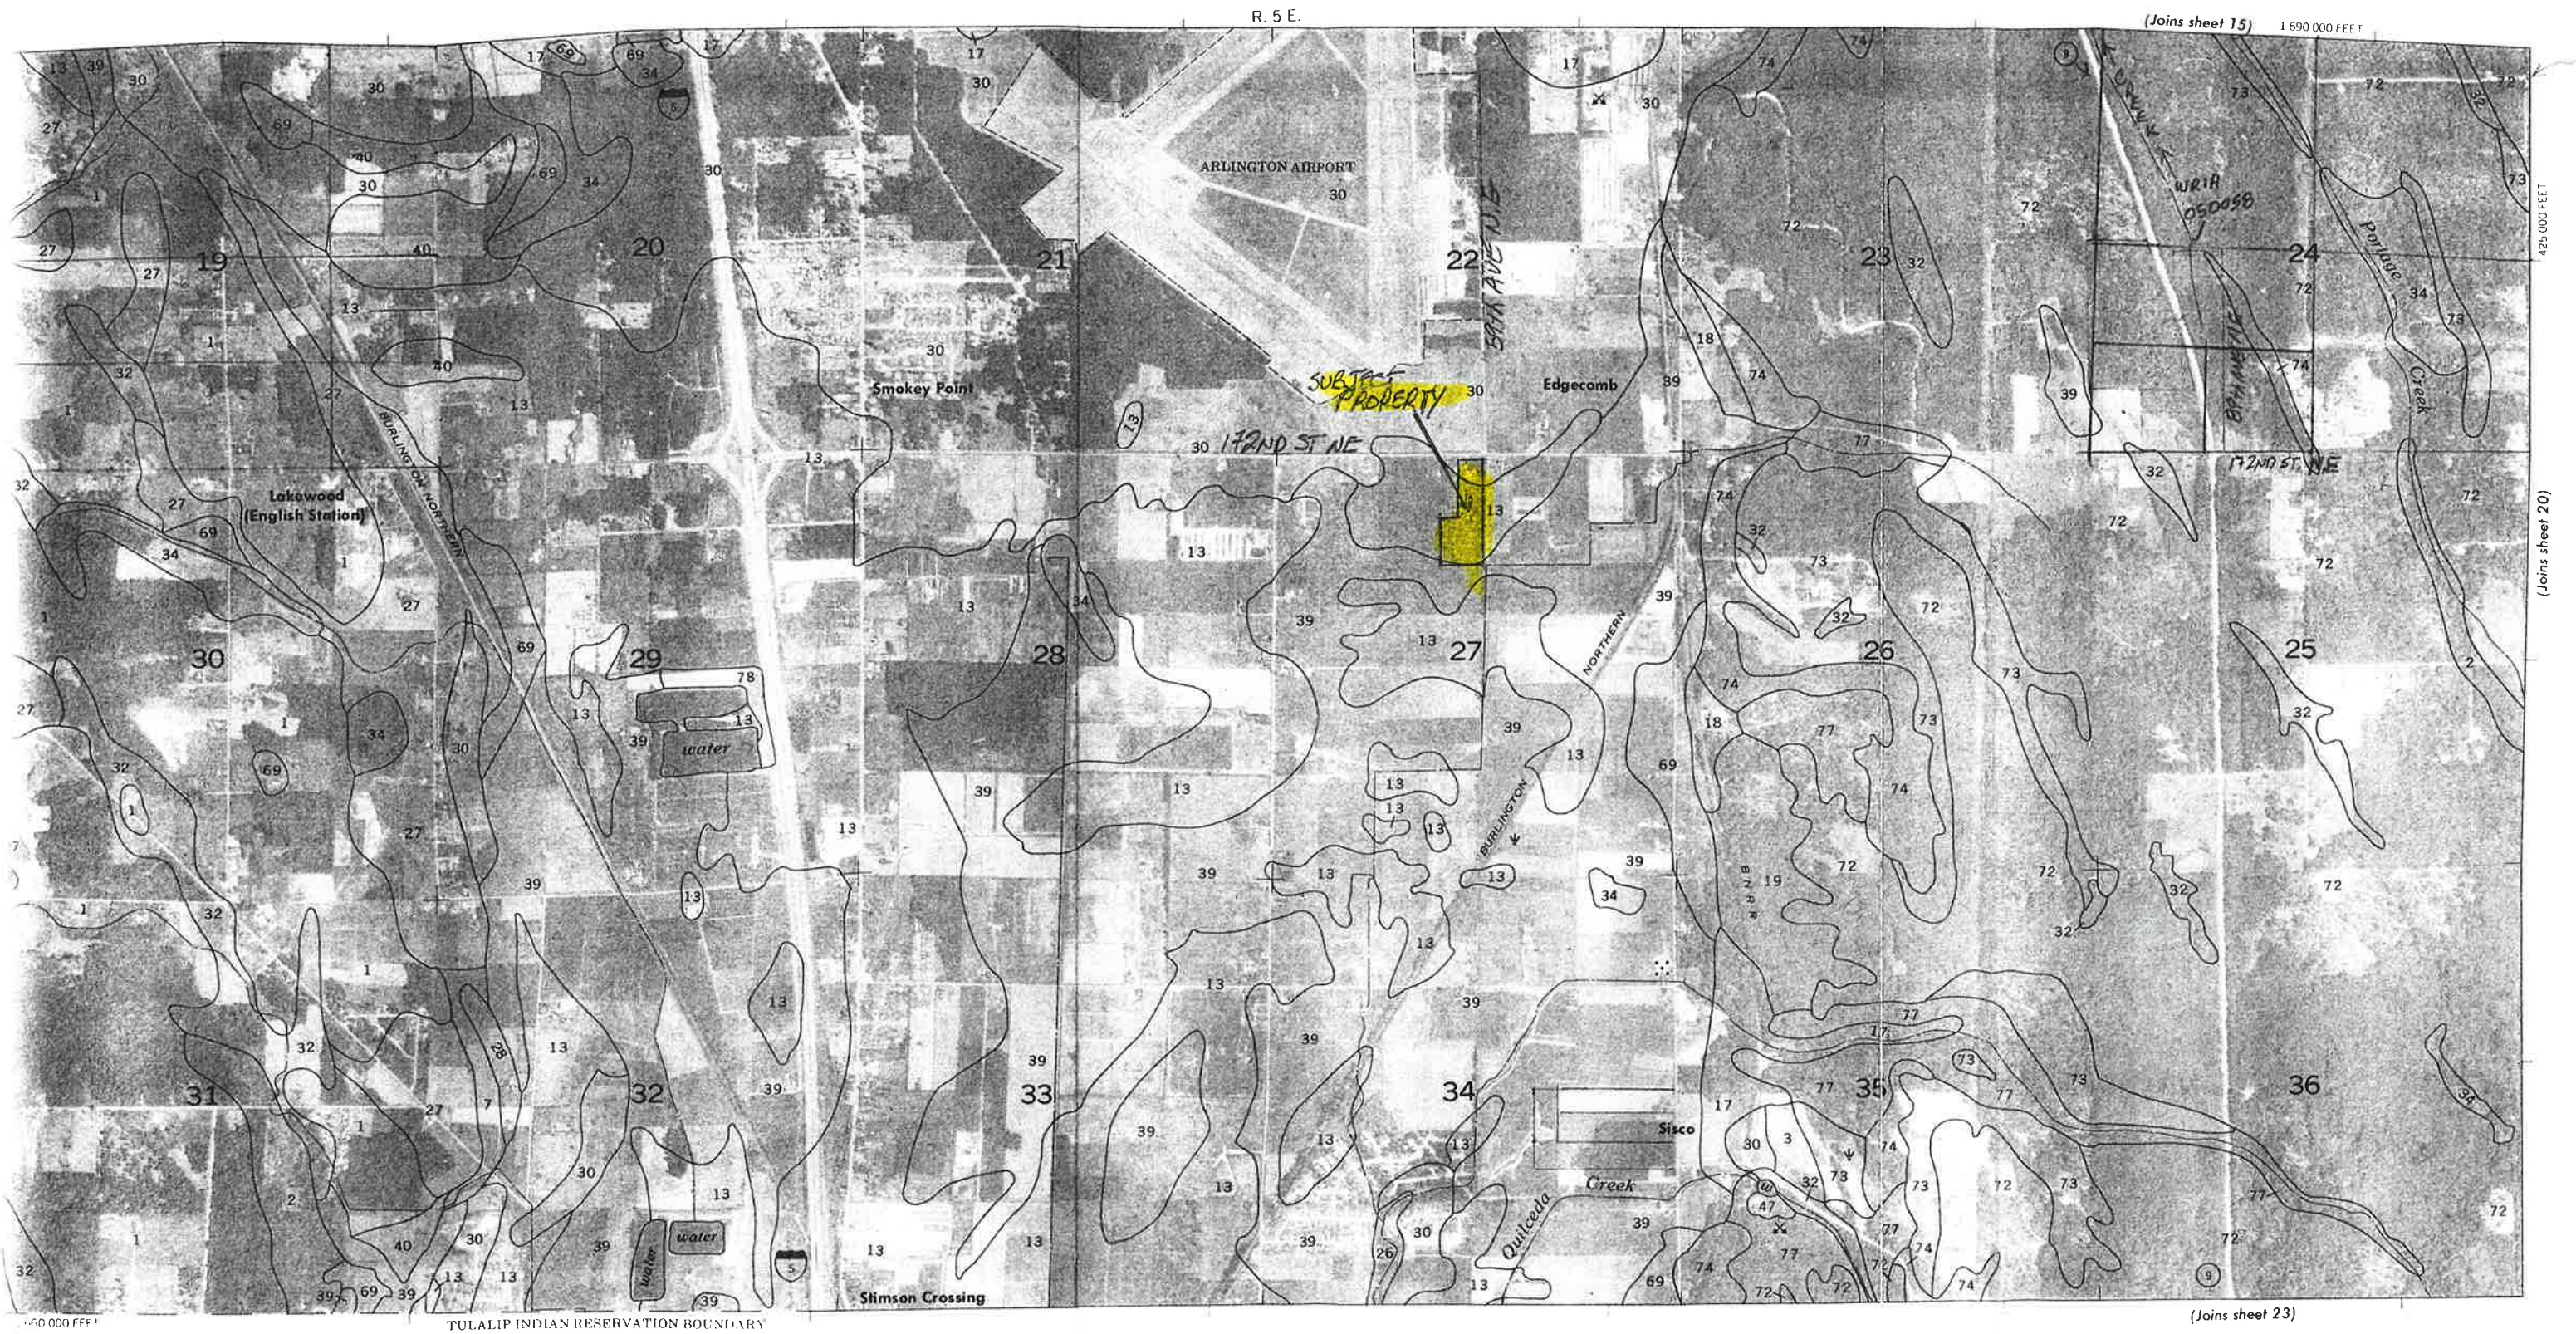
The mapped soil units (SMU) of the site and surrounding vicinity are described in US Department of Agriculture, Natural Resources Conservation Service (NRCS-SCS), “Soil Survey for Snohomish County Area, Washington”, July 1983. The Soil Map Units (SMU) occurring in the vicinity and on the subject property is shown on Sheet 19 in **Appendix B**.

Soil Survey of Snohomish County Area, Washington

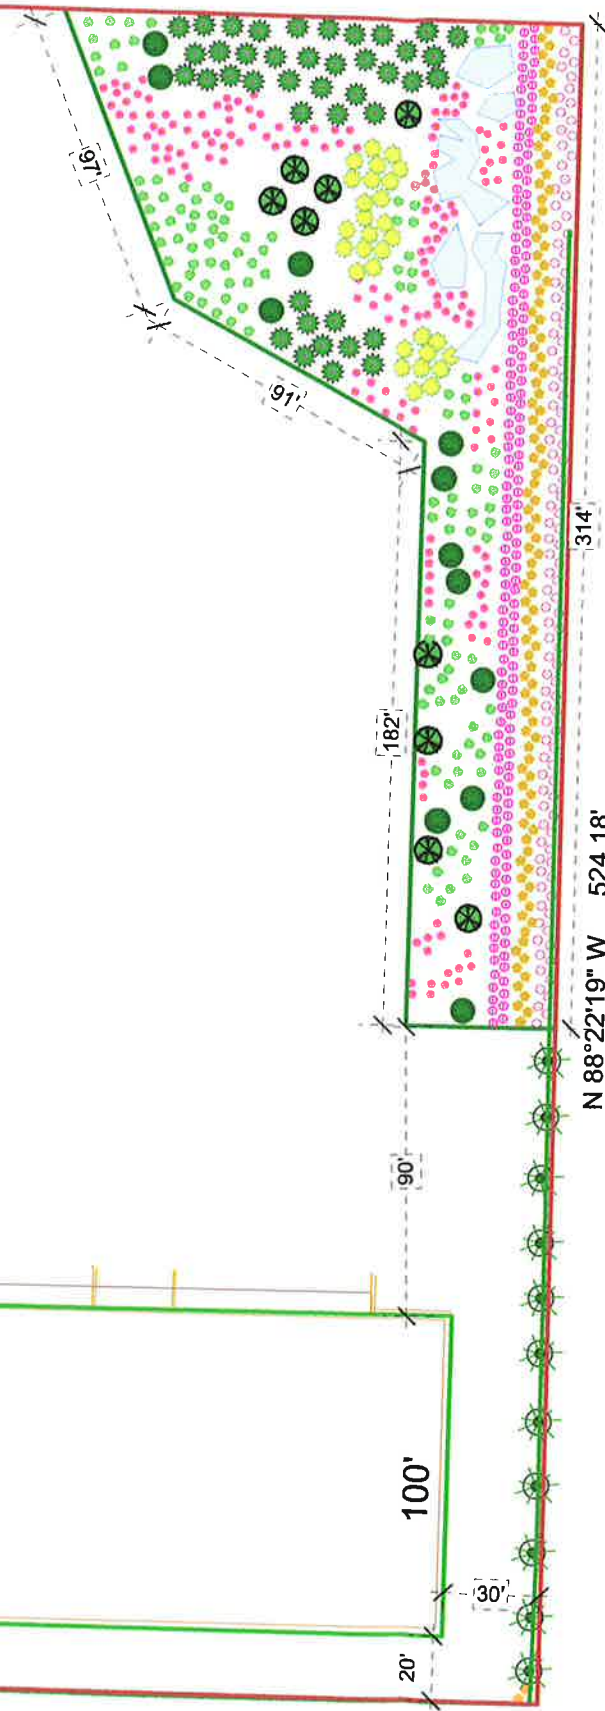
Symbol	Qty.	Scientific Name	Common Name
	11	<i>Juniperus communis</i>	Common juniper
	9	<i>Pinus contorta contorta</i>	Shore pine
	12	<i>Taxus brevifolia</i>	Pacific (western) yew
	40	<i>Crataegus phaenopyrum</i> <i>Crataegus suksdorfii</i>	Washington hawthorn Douglas hawthorn
	30	<i>Acer circinatum</i>	Vine maple
	115	<i>Rubus parviflorus</i>	Thimbleberry
	160	<i>Rosa nutkana</i>	Nootka rose
	162	<i>Cornus stolonifera</i> <i>Cornus sericea var. occidentalis</i>	Red-twig dogwood
	116	<i>Rubus spectabilis</i>	Salmonberry
	112	<i>Salix sessilifolia</i>	Soft-leaved willow

Plant Specifications

All plants will be native to the Pacific Northwest, Puget Sound Region. Plants shall be obtained from a native plant nursery or from an approved salvage nurseryman.
