**Targeted Drainage Report
for the
*BAKER/ELLIS PROPERTY***

Prepared for:
James Pontak
Anthem Self Storage Corporation
8115 Broadway #204
Everett, WA 98203

Prepared by:
Derek I. Hann, E.I.T.

March 12, 2009

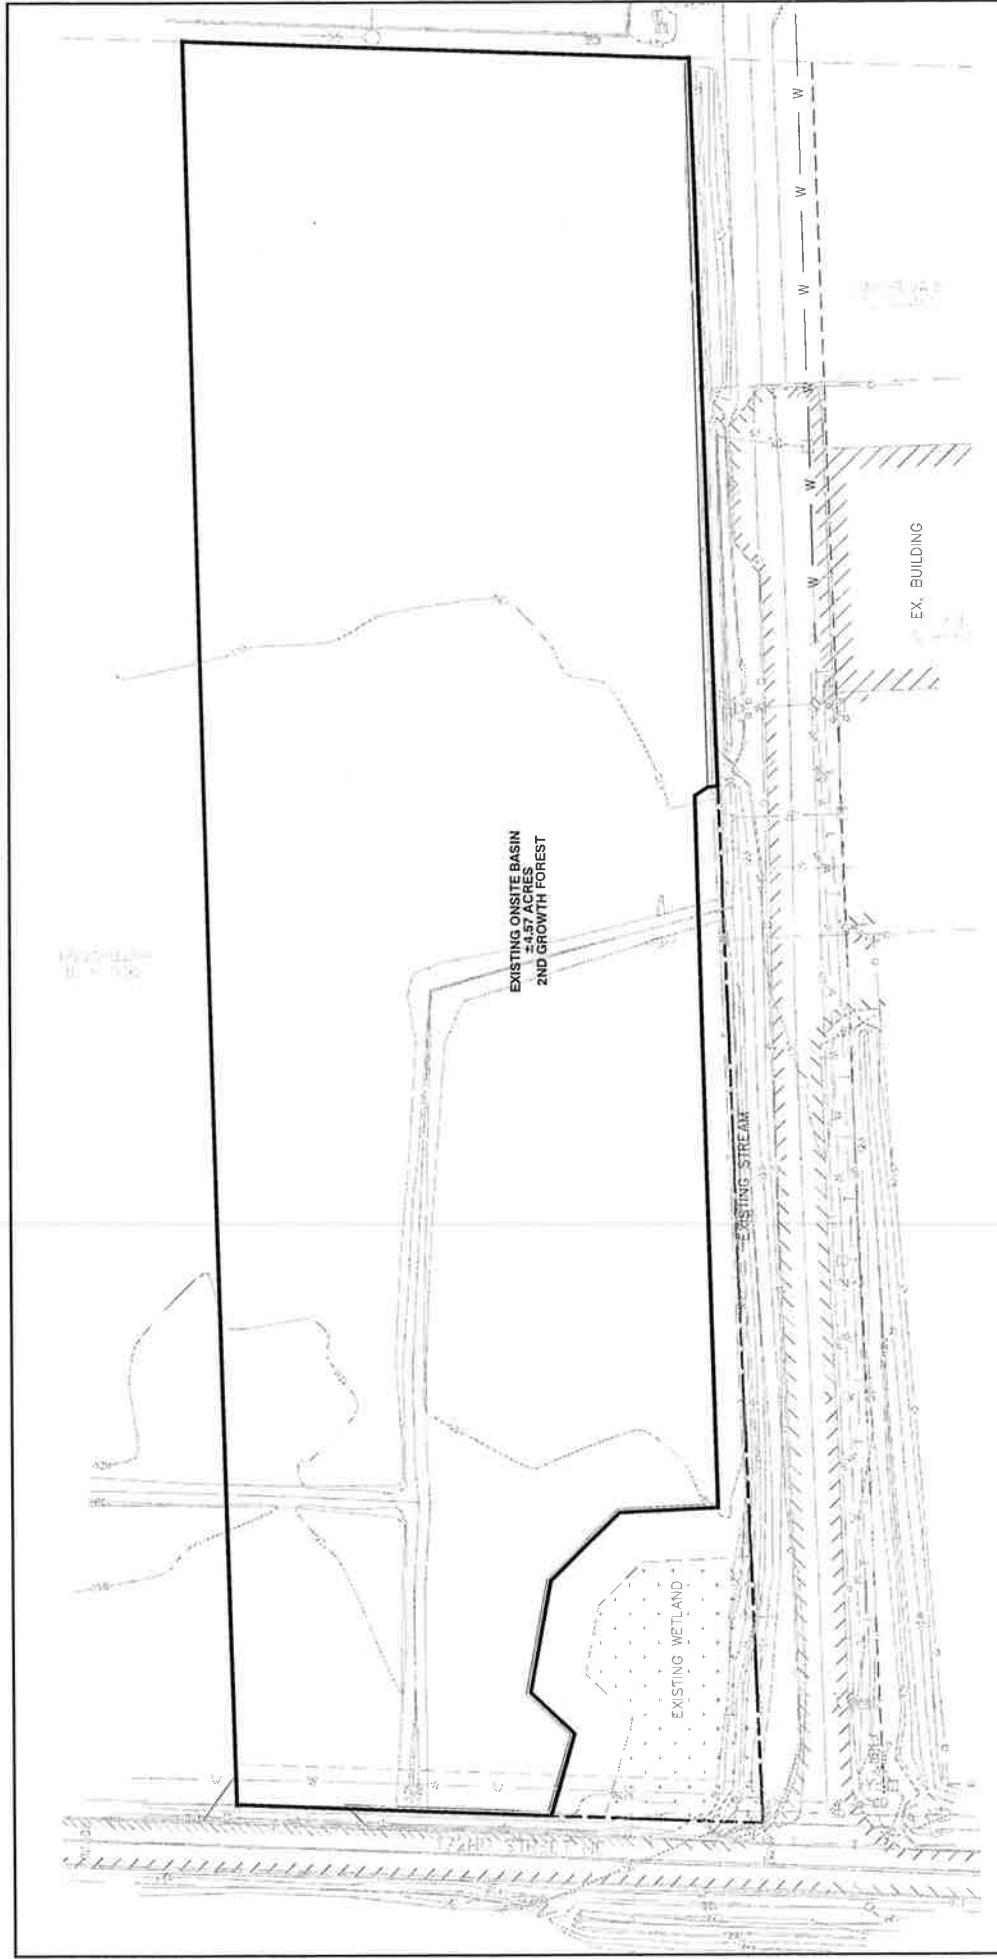
**BAKER/ELLIS PROPERTY
EXISTING CONDITIONS
BASIN MAP**

Existing drainage patterns for the site suggest that all onsite rainwater infiltrates into the existing soils. This is consistent with the data contained within the Geotechnical Report.

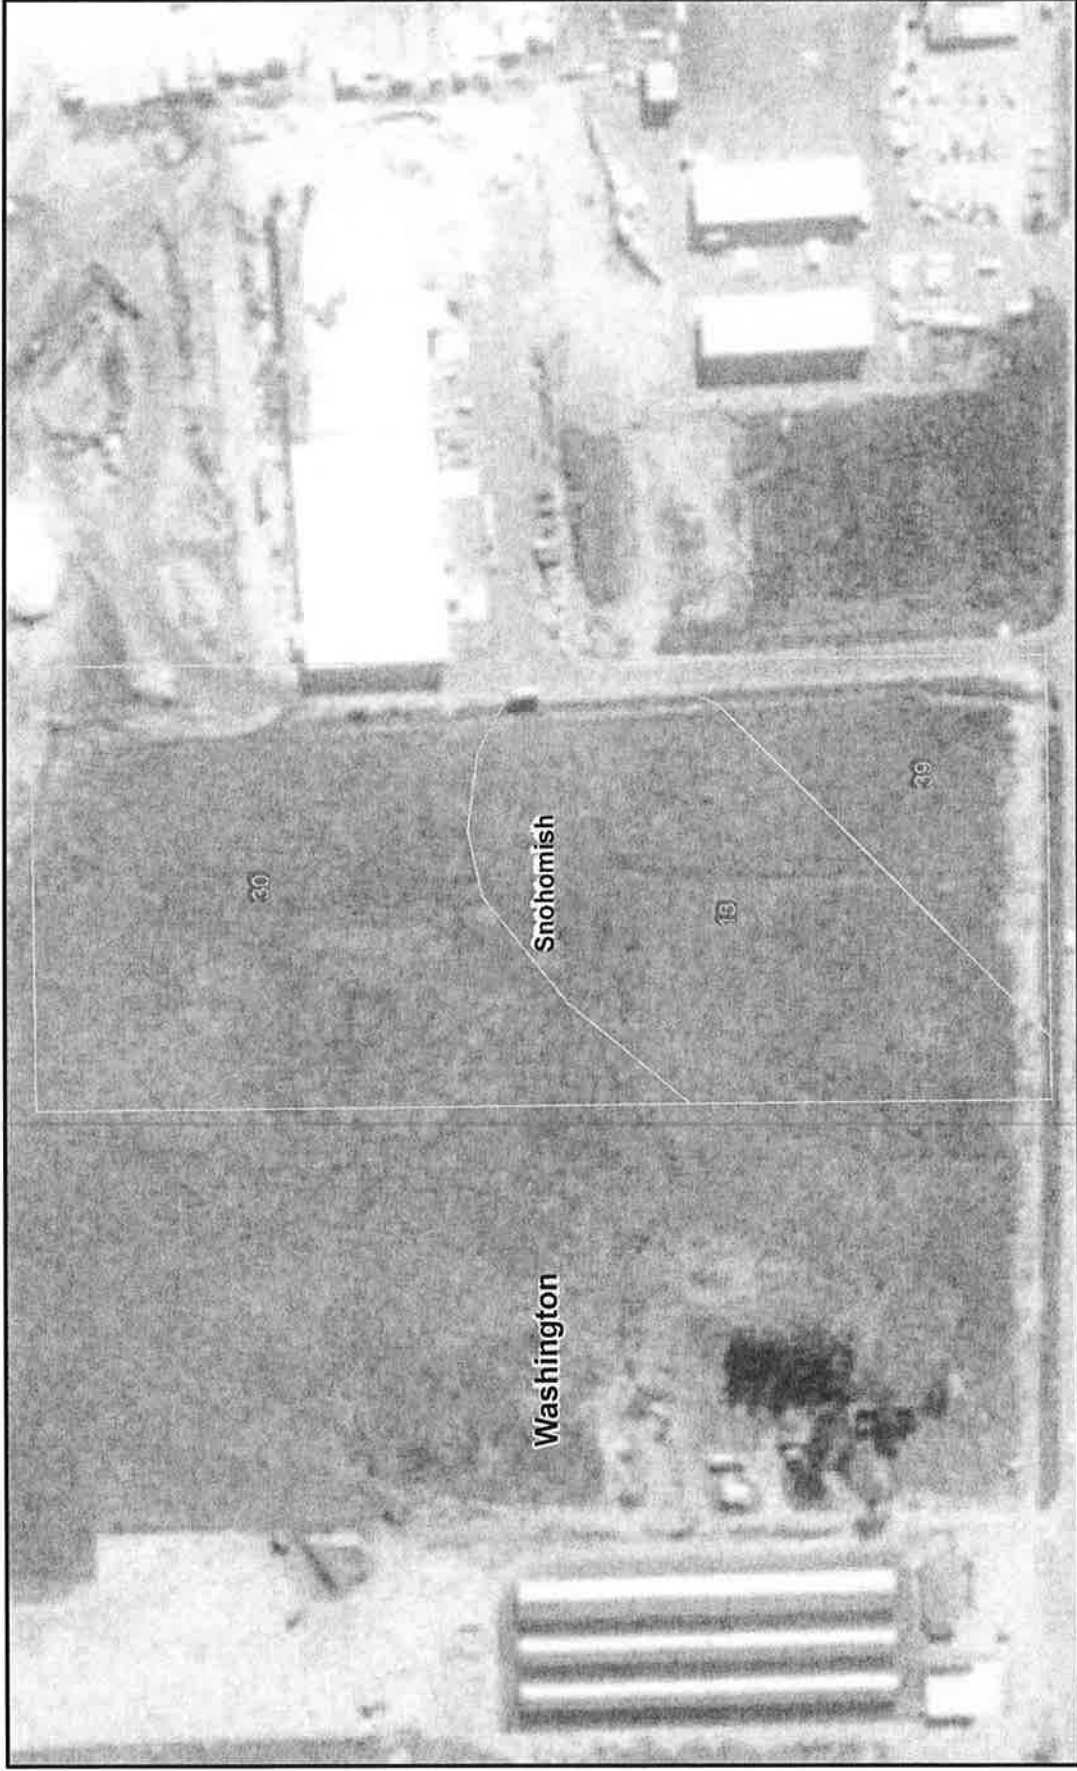
BAKER/ELLIS SOILS MAP

According to the SCS Soil Survey for Snohomish County the predominant soil types on this site is are Custer fine sandy loam, hydrologic group C, Symbol 13, Lynnwood loamy sand, hydrologic group A, Symbol 30 and Norma Loam, hydrologic group D, Symbol 39 (see appendix for Soils Map).
