Police Station / City Hall

GEOTECHNICAL AND
ENVIRONMENTAL
DATA

Subsurface Exploration, Geologic Hazard, and
Preliminary Geotechnical Engineering Report

ARLINGTON CIVIC CENTER

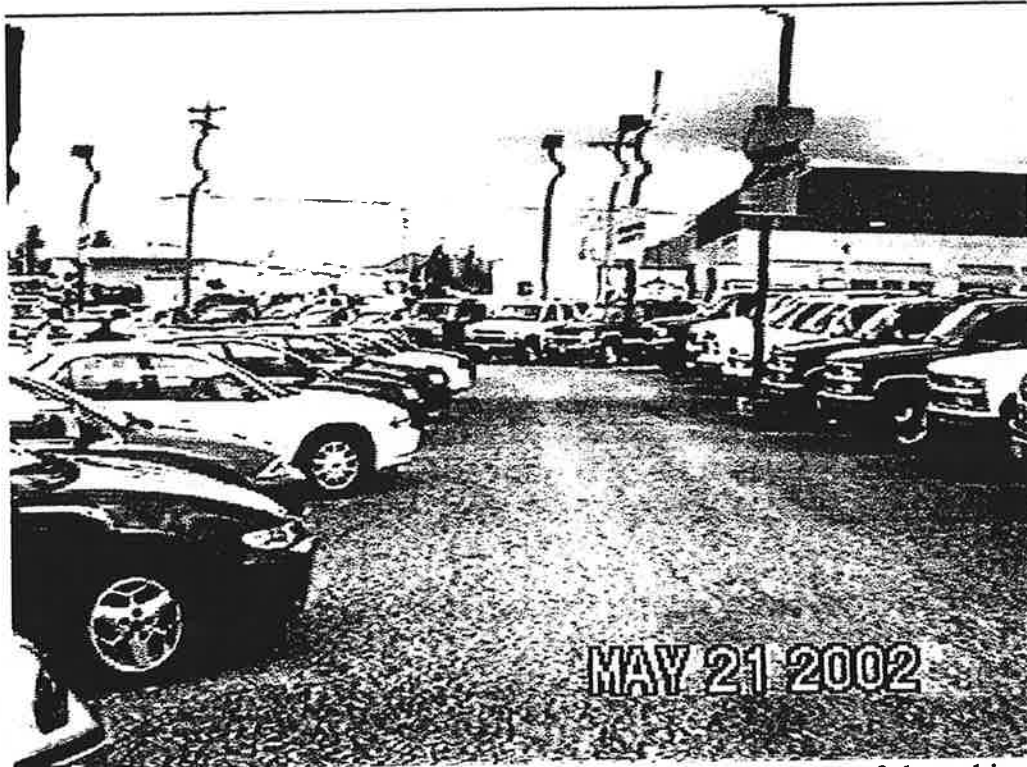
PHOTOGRAPH 1. Photograph looking north from the center of the subject property. The main Dwayne Lane car dealership can be seen in the back left corner.

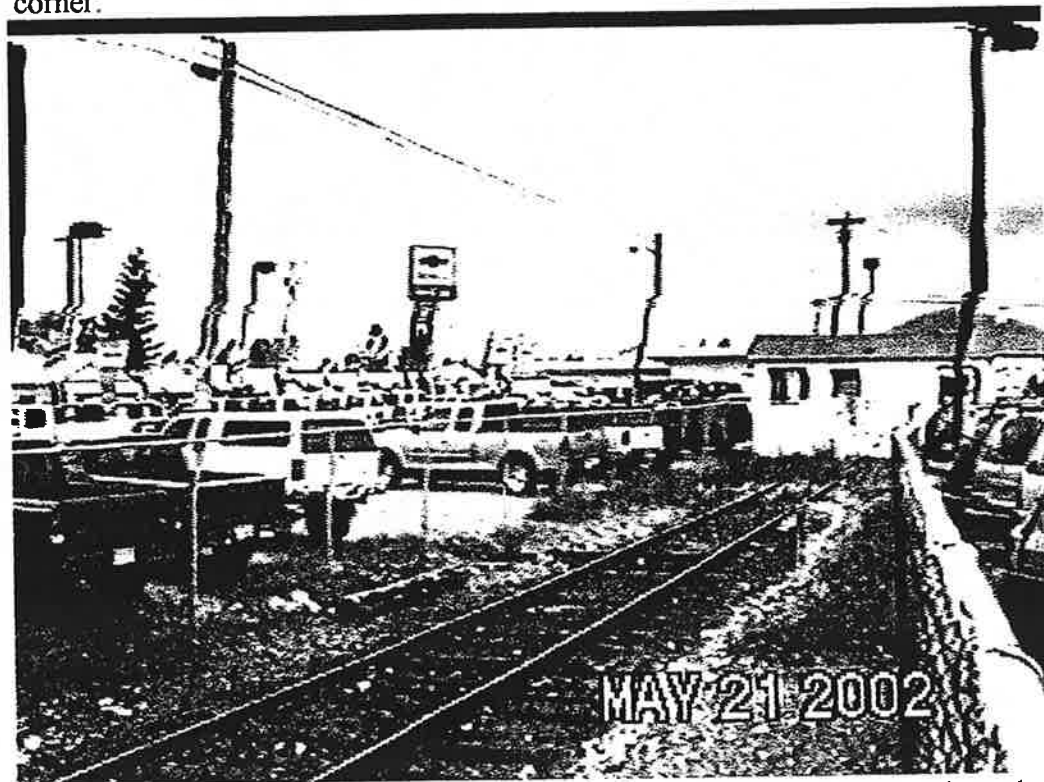
PHOTOGRAPH 2. The parking lot grade is about 2 feet higher than the tracks. The old tracks may be covered with fill. The small building at the end of the tracks is currently a sales office for Dwayne Lane Chevrolet.

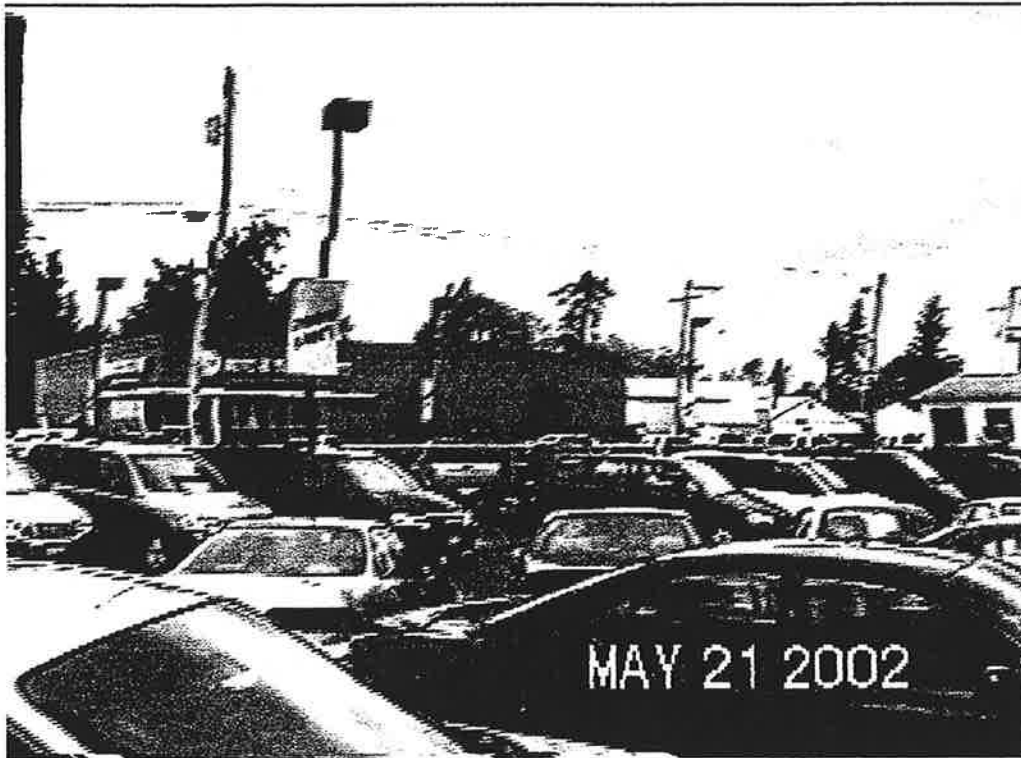
PHOTOGRAPH 3. Looking to the northwest across the subject property towards the Sunshine Laundry and Cleaner and NAPA Auto Parts buildings.

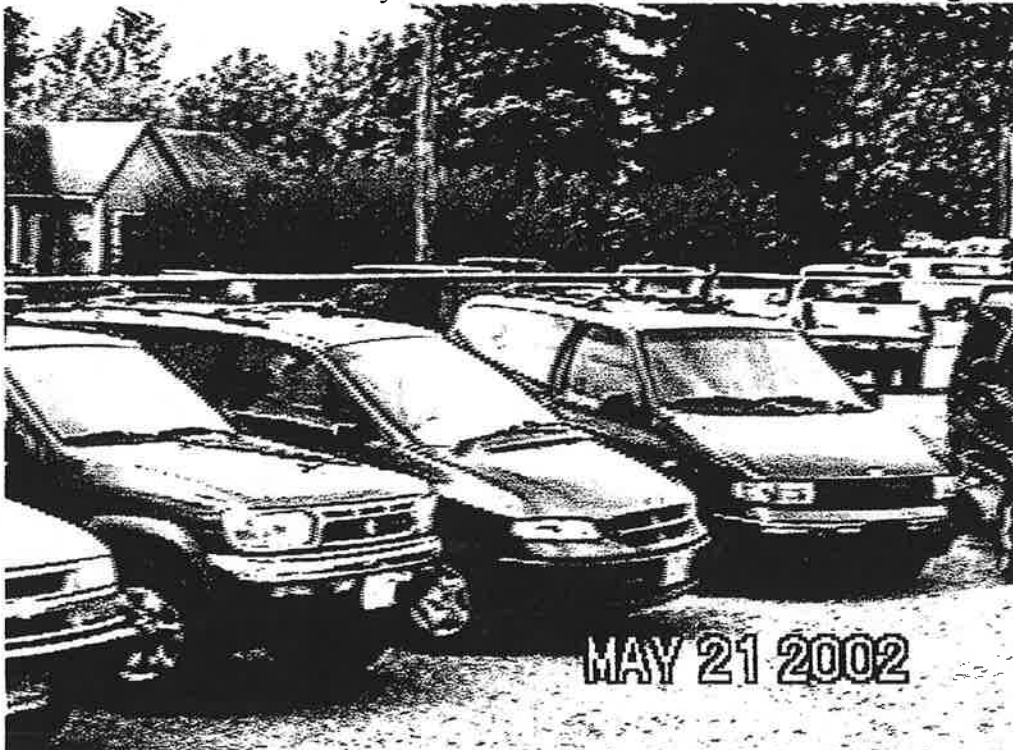
PHOTOGRAPH 4. The subject property is occupied by Dwayne Lane's used vehicle lot. There did not appear to be any significant oil stains indicating leakage of automobile related fluids on the property.

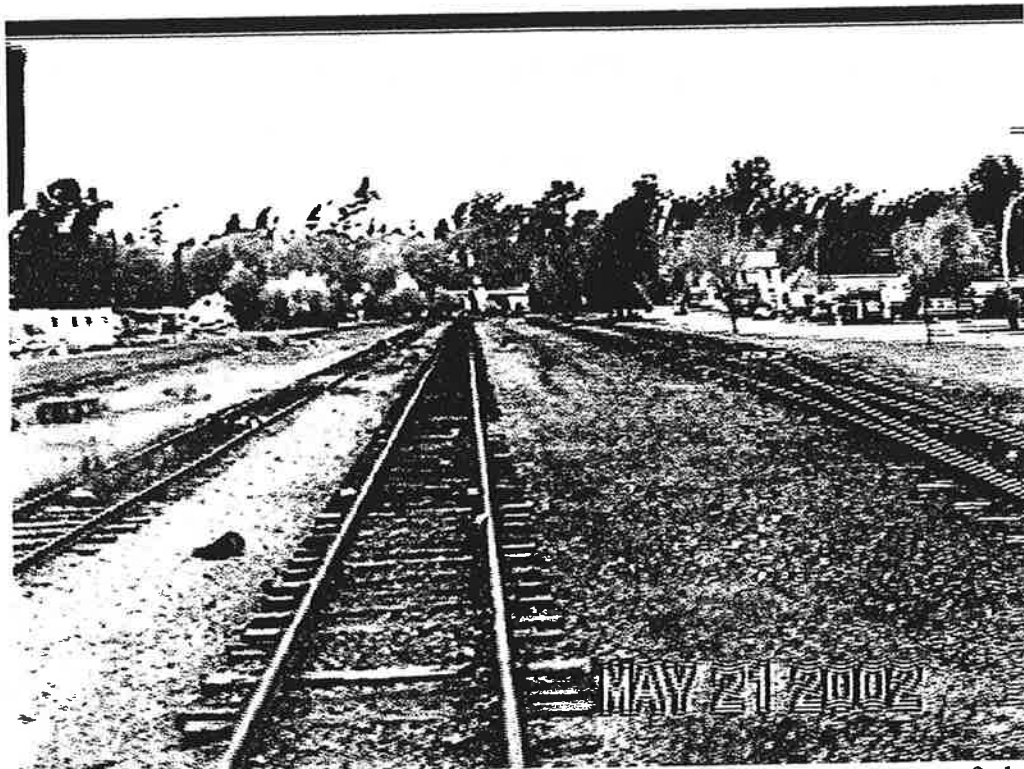
PHOTOGRAPH 5: View looking south from the subject property of the BNSFE property.

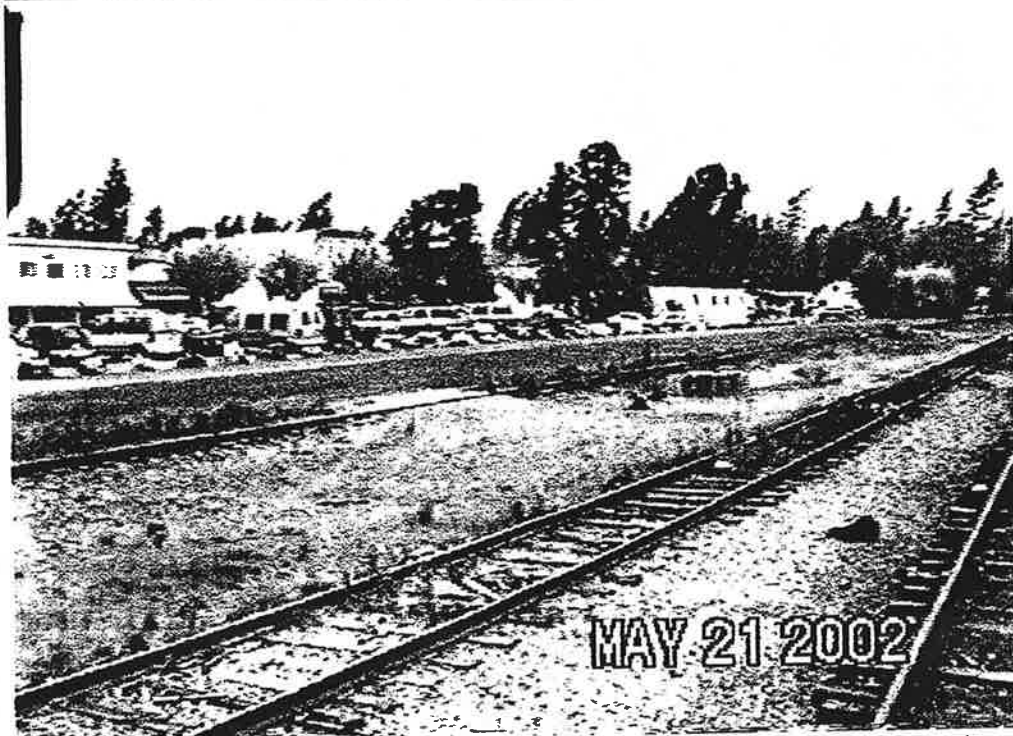
PHOTOGRAPH 6. The City of Arlington owns property east and southeast of the subject property. A bulk fueling station was reportedly located where cars are now parked.

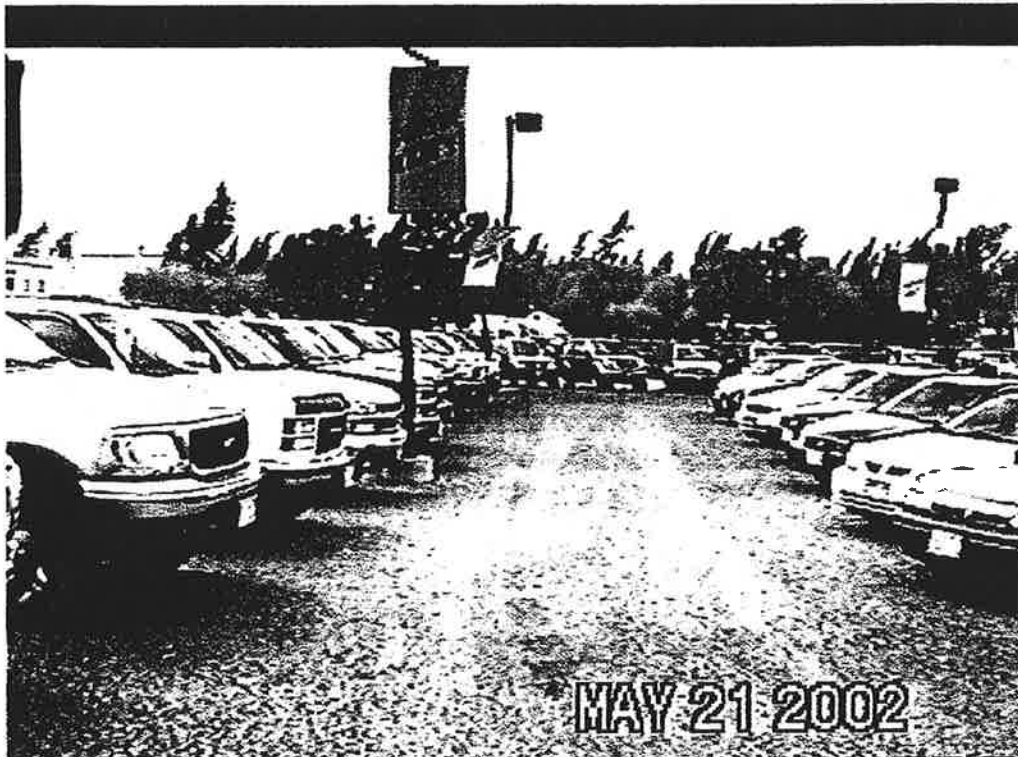
PHOTOGRAPH 7. Another view of the vehicle lot from 3rd Ave looking south.

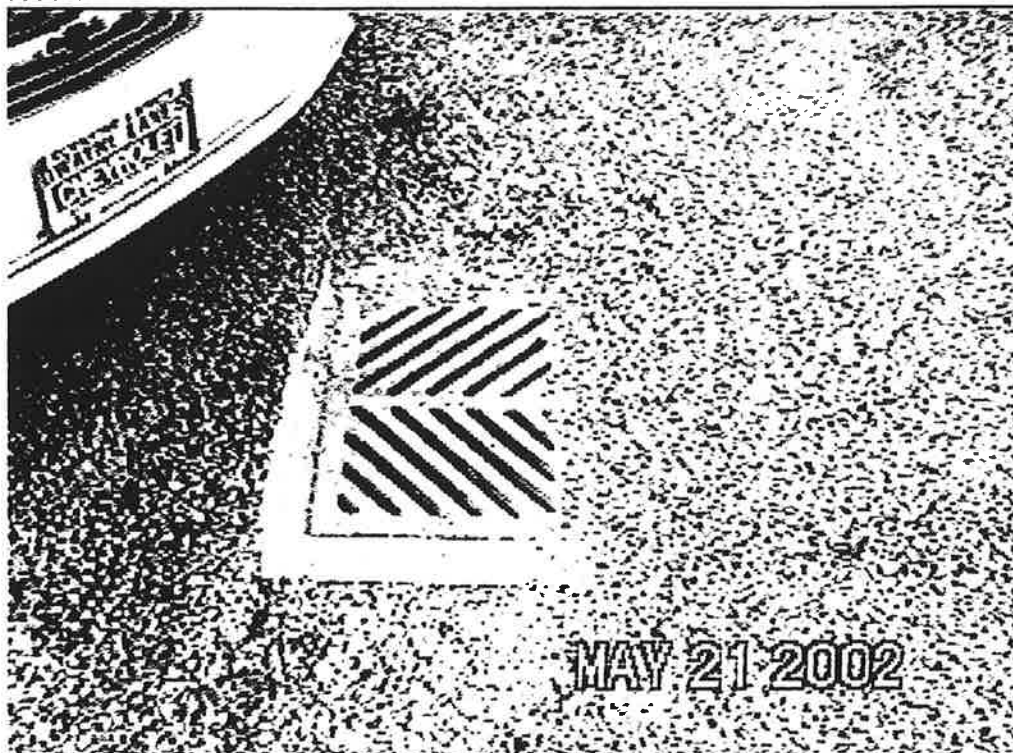
PHOTOGRAPH 8. A storm drain is present on the eastern portion of the subject site.
