# BRIDGE INSPECTION REPORT

Agency: Snohomish County

Bridge No.	91	Page 1 of 2	Structure Type
Bridge Name	SOUTH SLOUGH #91	Route	96855 Intersecting SOUTH SLOUGH
Structure ID	08084500	MilePost	9.40 Location .3 S JCT SR 530

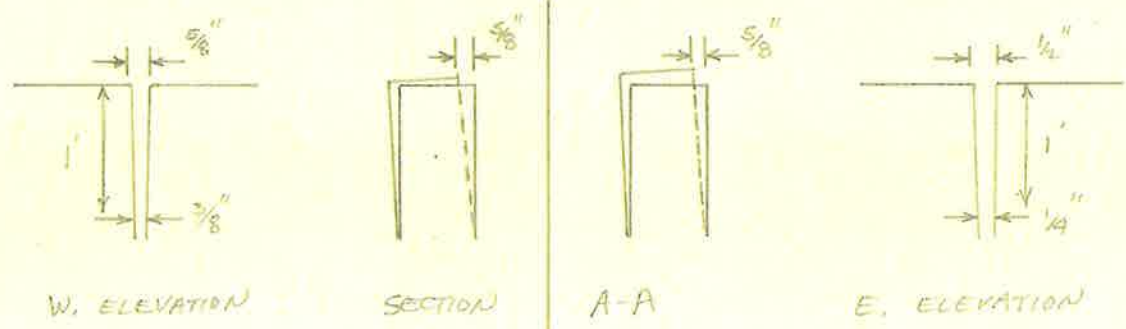
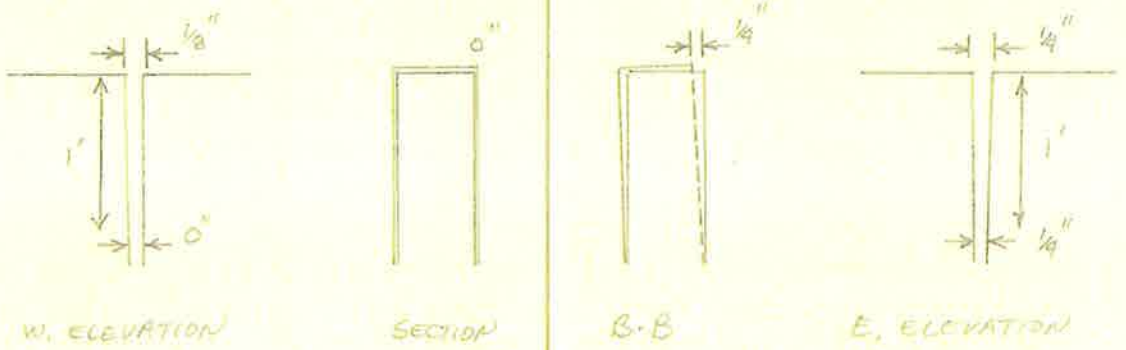
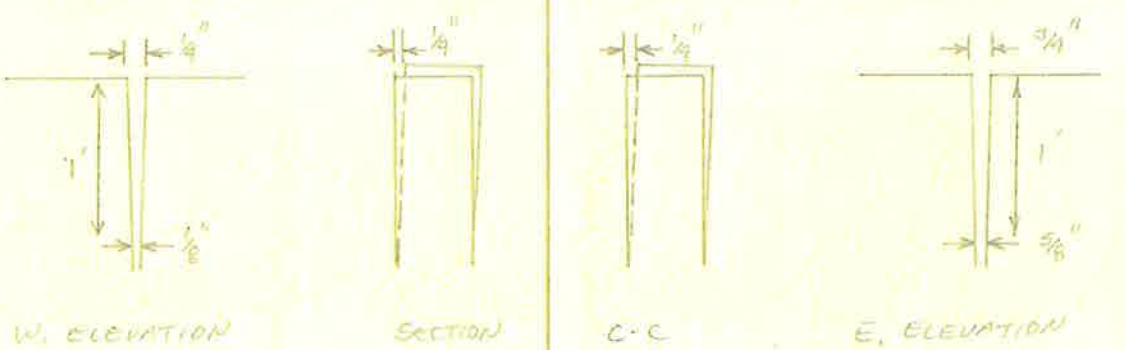
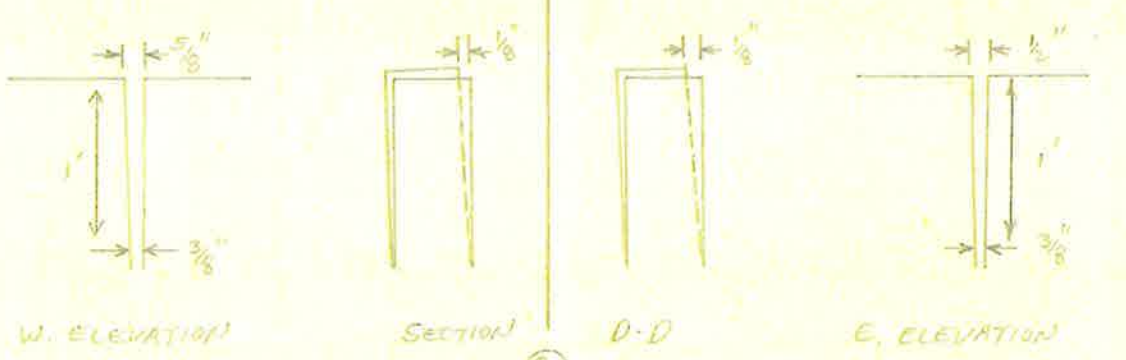
(4)

4. RAILS POOR - PCC / COVERED "/>MOSS - DIFFERENTIAL SETTLEMENT MAJOR SPALLS,  
MAJOR SCALE - EXPOSED RE-STEEL - SECTIONAL LOSS - OPEN JOINTS

LEFT RAIL
