Subject: Subsurface Exploration, Geologic Hazard, and  
Geotechnical Engineering Report  
Magnolia Meadows  
Arlington, Washington

Subsurface Exploration, Geologic Hazard,  
and Geotechnical Engineering Report

**MAGNOLIA MEADOWS**

Project No. KE04216A  
May 7, 2004

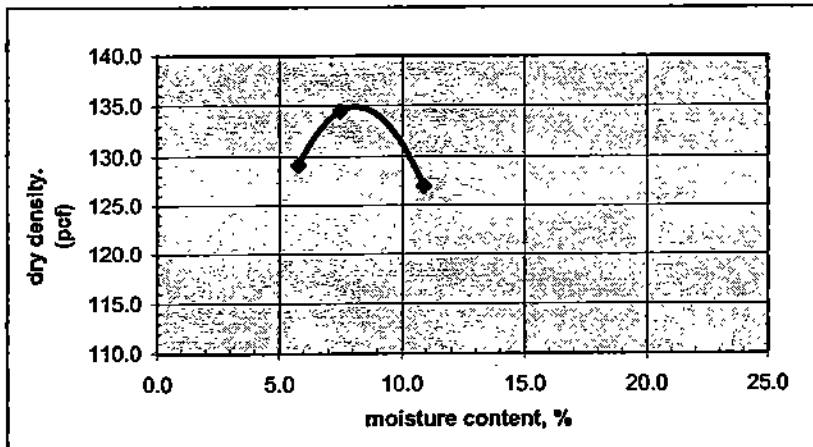
Percent passing 3/4" sieve:	93%	ASTM D1557 Method C	Automatic Tamper
-----------------------------	-----	---------------------	------------------

A	Mold Number	1	2	3	Remarks
B	Water Added	dry	dry	dry	
C	Wt. of Wet Soil + Mold (lb)	24.090	24.370	23.782	
D	Wt. of Mold (lb)	13.530	13.530	13.530	
E	Wt. of Wet Soil (lb)	10.560	10.840	10.252	
F	Wet Density, (pcf)	140.800	144.533	136.694	
G	Wt. of Pan (lb)	1.160	1.025	1.025	
H	Wt. of Wet Soil + Pan (lb)	11.690	10.210	10.415	
J	Wt. of Dry Soil + Pan (lb)	10.655	9.570	9.900	
K	Wt. of Water (lb)	1.035	0.640	0.515	
M	Wt. of Dry Soil (lb)	9.495	8.545	8.875	
N	Moisture Content (%)	10.9	7.5	5.8	
O	Dry Density (pcf)	127.0	134.5	129.2	
Z	For a 6 inch mold: Z = 0.075		For a 4" mold: Z = 0.0333

Test Results:	
Optimum Moisture Percentage:	8.0
Maximum Dry Density:	135.0

Correction for oversize: ASTM D4718	
Corrected Moisture Percentage:	7.4
Corrected Maximum Dry Density	136.9
