**CONSTRUCTION
DRAINAGE REPORT
FOR
BEN WELLS
OFFICE BUILDING
City of Arlington
CFN: PLN 20090012**

**Prepared By: Brian R Lindsay
Peak Engineering, Inc.**

**March 31, 2009
Peak Job #1093**

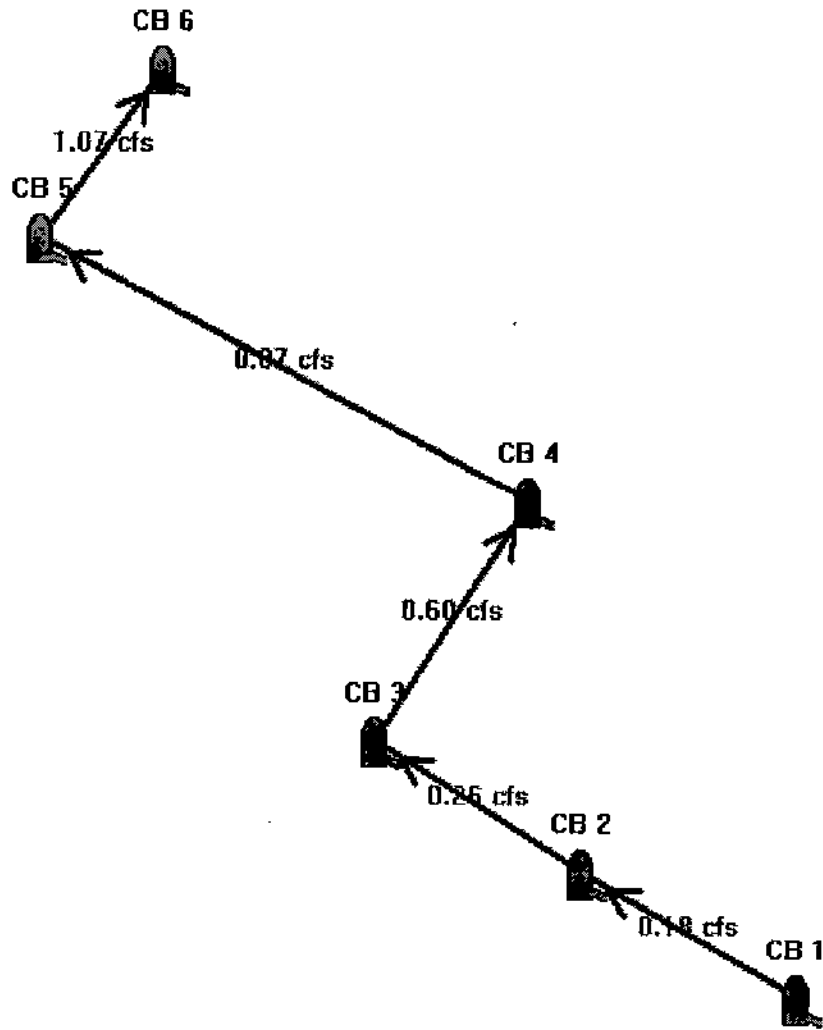
DOWNSTREAM DRAINAGE COURSE SCHEMATIC
NTS

BACKWATER HYDRAULIC ANALYSIS

- CB 1 TO CB 2: 8" Diam 0.18 cfs @ 0.7700%
- CB 2 TO CB 3: 8" Diam 0.26 cfs @ 0.1000%
- CB 3 TO CB 4: 8" Diam 0.60 cfs @ 0.5900%
- CB 4 TO CB 5: 8" Diam 0.87 cfs @ 1.0000%
- CB 5 TO CB 6: 8" Diam 1.07 cfs @ 3.3000%

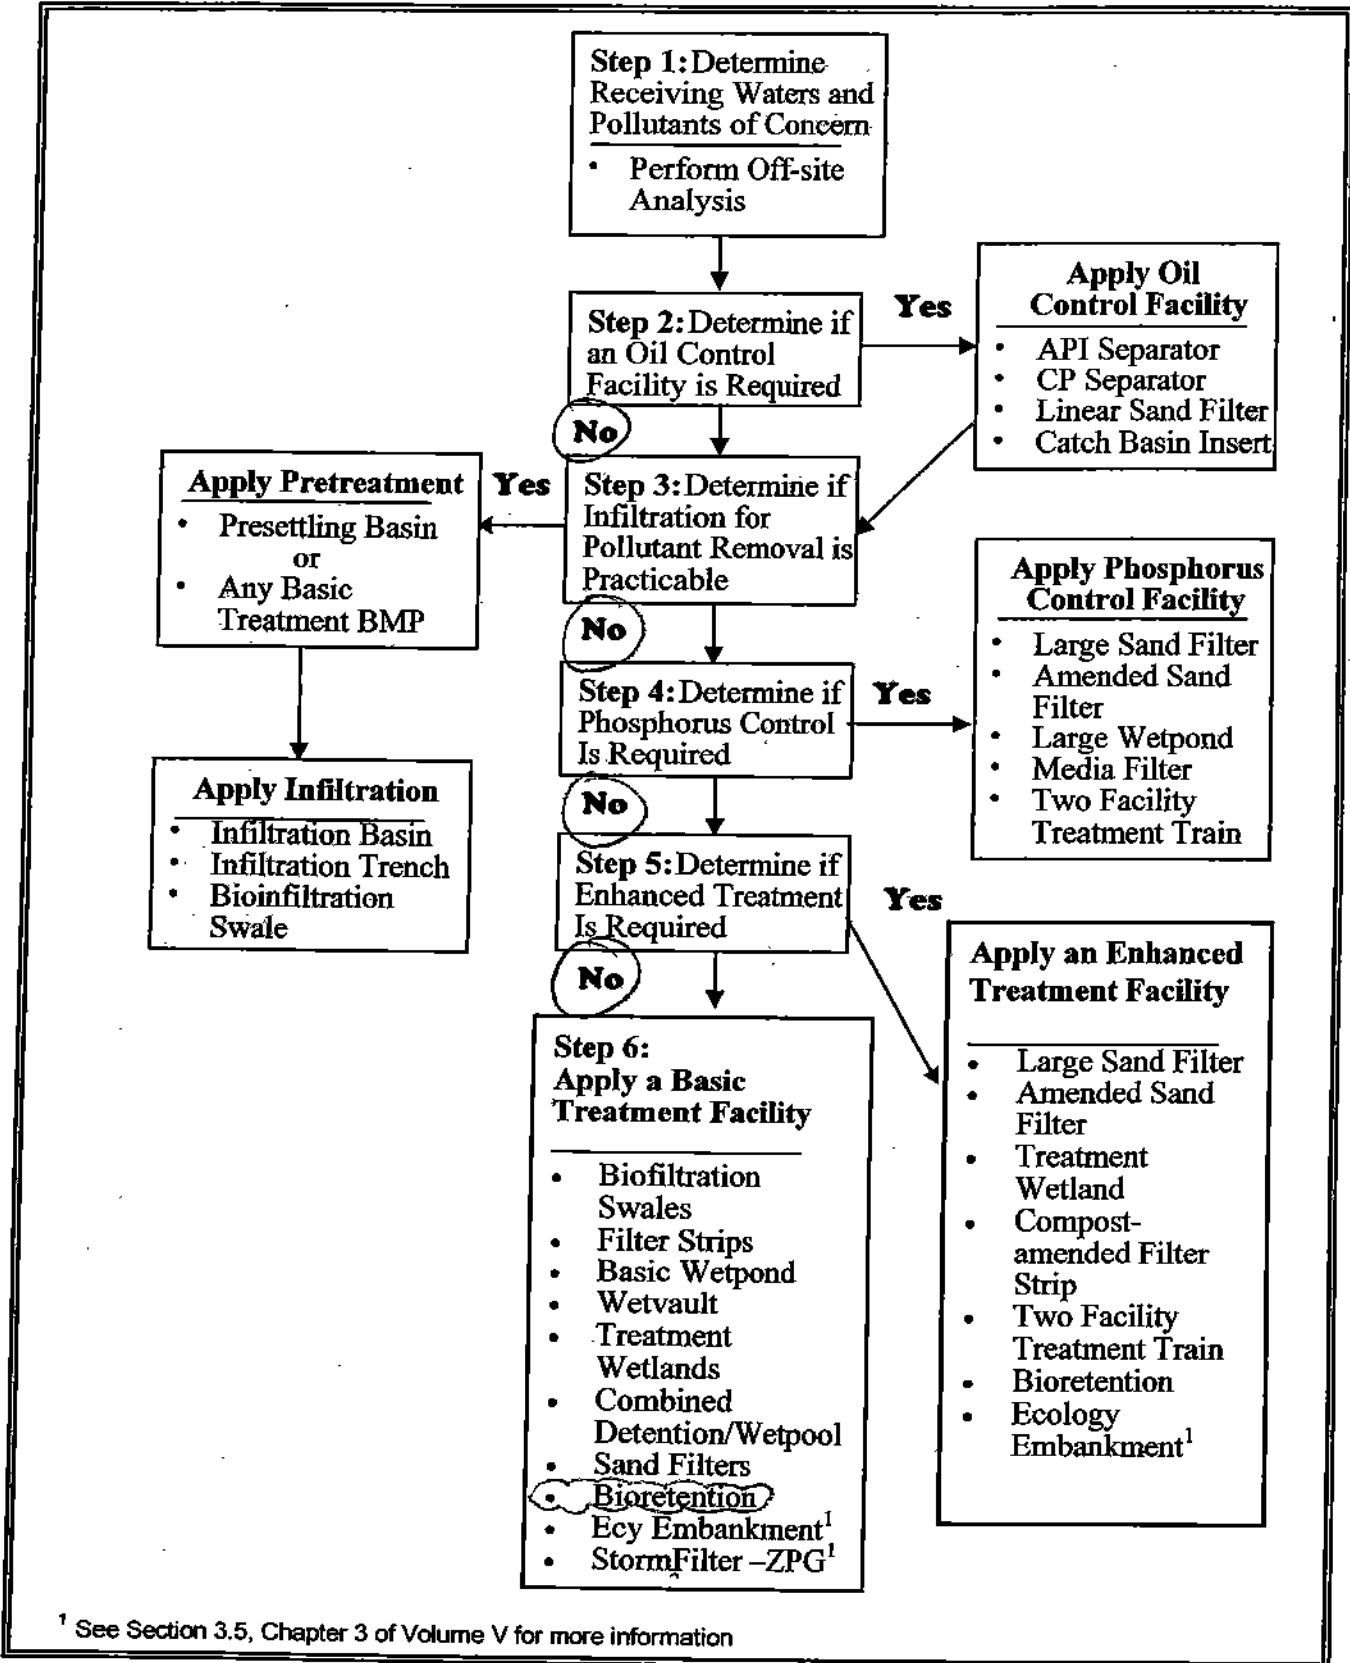
Figure 4.1 Treatment Facility Selection Flow Chart

¹ See Section 3.5, Chapter 3 of Volume V for more information

To meet water quality criteria, storm drainage from pollution generating surfaces will be directed to a Rain Garden (Bioretention area) adjacent to Newberry St. The treatment facilities were selected per Figure 4.1 (attached to the Appendix of this report) Treatment Facility Selection Flow Chart in Volume I of the DOE Manual. The Rain Garden has been designed and will be planted in accordance with criteria found in the Low Impact Development Technical Guidance Manual for Puget Sound. A dead storage volume of 418 cf (440 cf provided within 35 % void
