**CONSTRUCTION
DRAINAGE REPORT
FOR
ARLINGTON SQUARE
City of Arlington**

**Prepared By: Brian R Lindsay
Peak Engineering, Inc.**

RECEIVED Supplemental Construction Drainage Analysis: April 28, 2008 (brl)
JUL 11 2008 Revised per city review: July 9, 2008
Peak Job #05627

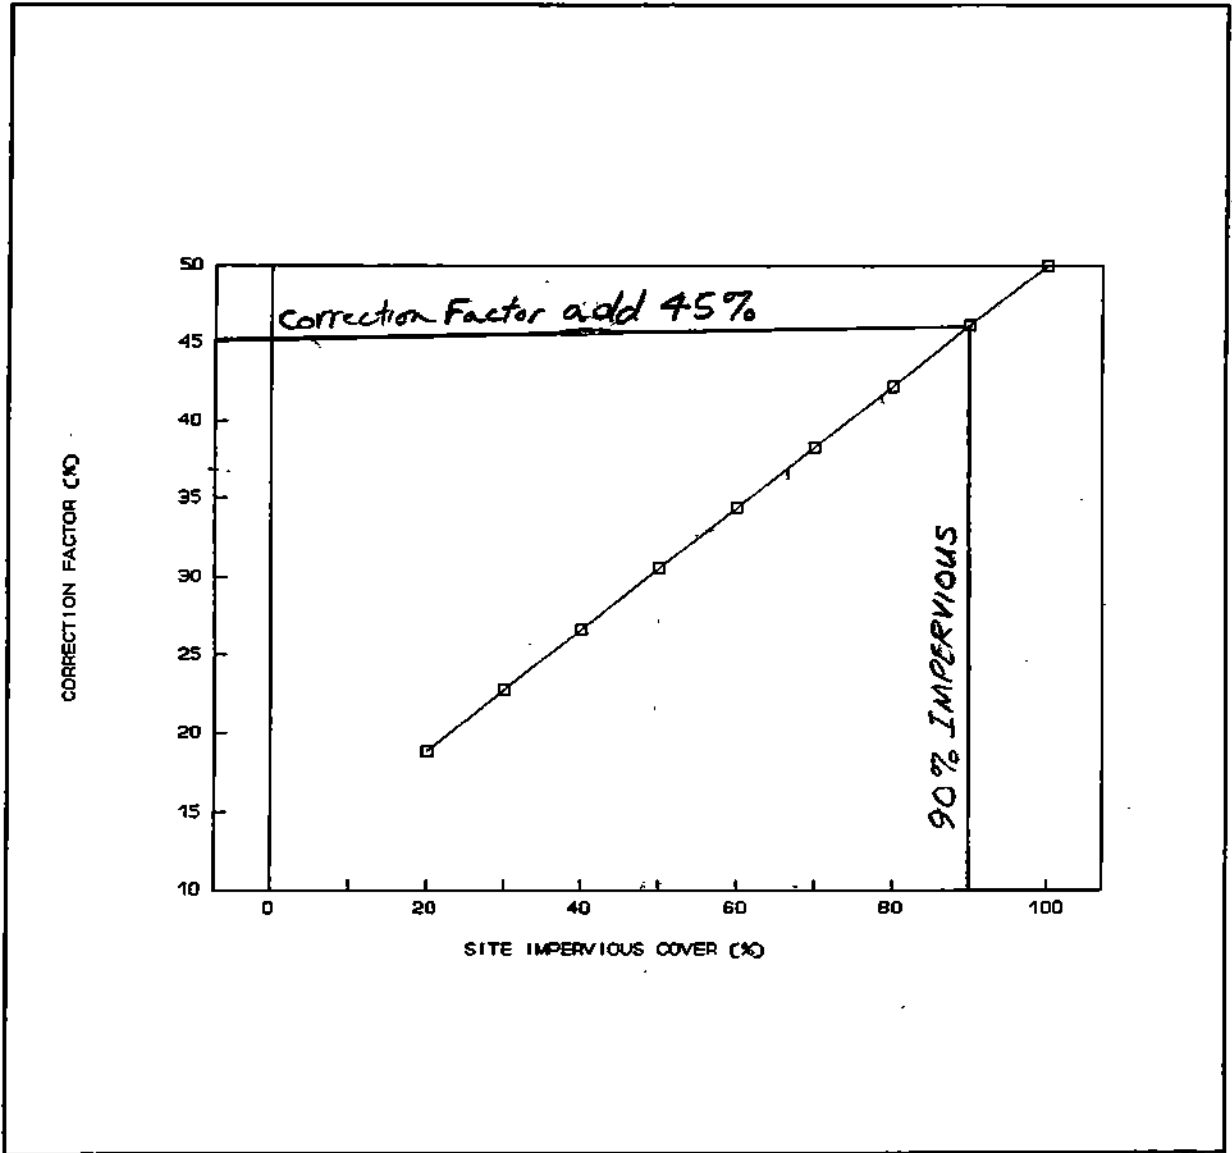
FIGURE III-1.1
Volume Correction Factor to be Applied to
Streambank Erosion Control BMPs
Based on Site Impervious Cover
