**Storm Drainage Report
for
Oosterwyk Chiropractic Clinic**

SITE LOCATION:
113 Division St.
Arlington, WA 98223

Brian G. Harron, P.E.
Patrick Harron & Associates, LLC
14900 Interurban Ave. S. Suite 279
Seattle, WA 98168

PHA Project#: 07905
Date: March 2008
Revised May 2008

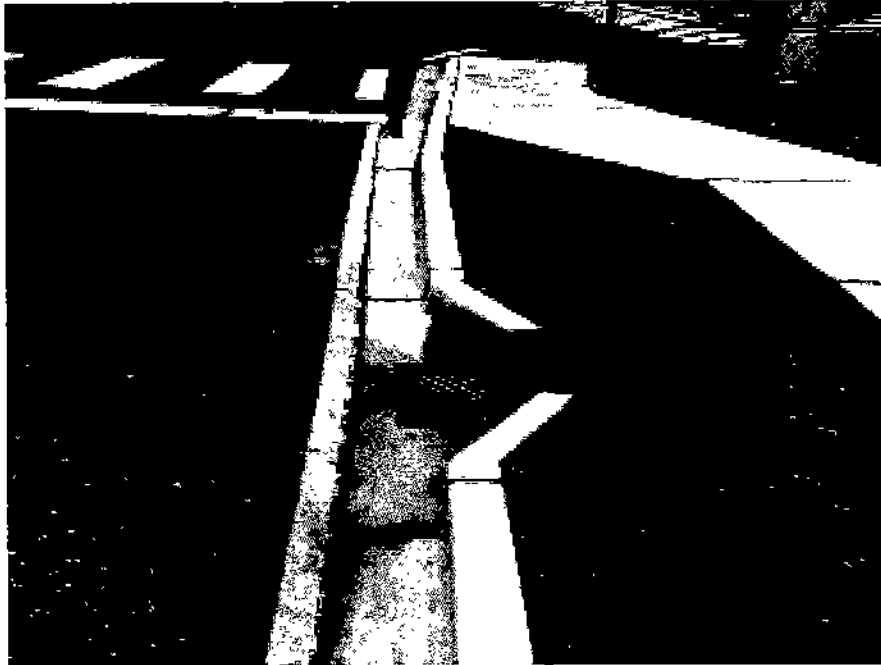
Catchbasin near NE corner of Hwy 9 and Division St.

From this catchbasin the flow is routed thru the City storm sewer system to a regional pond.

Flow from the Division St. Frontage flows westerly along the frontage to a Catchbasin near the northeast corner of the Hwy 9 and Division St. Intersection.

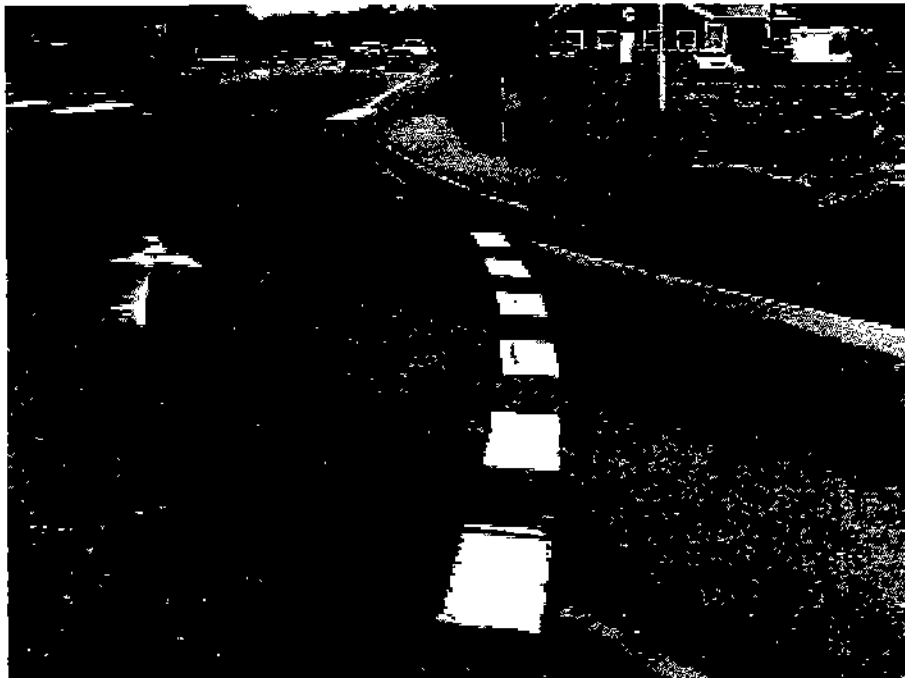
NW corner of Division St and West Ave intersection, the high point in the curb is near where the white striped line intersects the curb line.

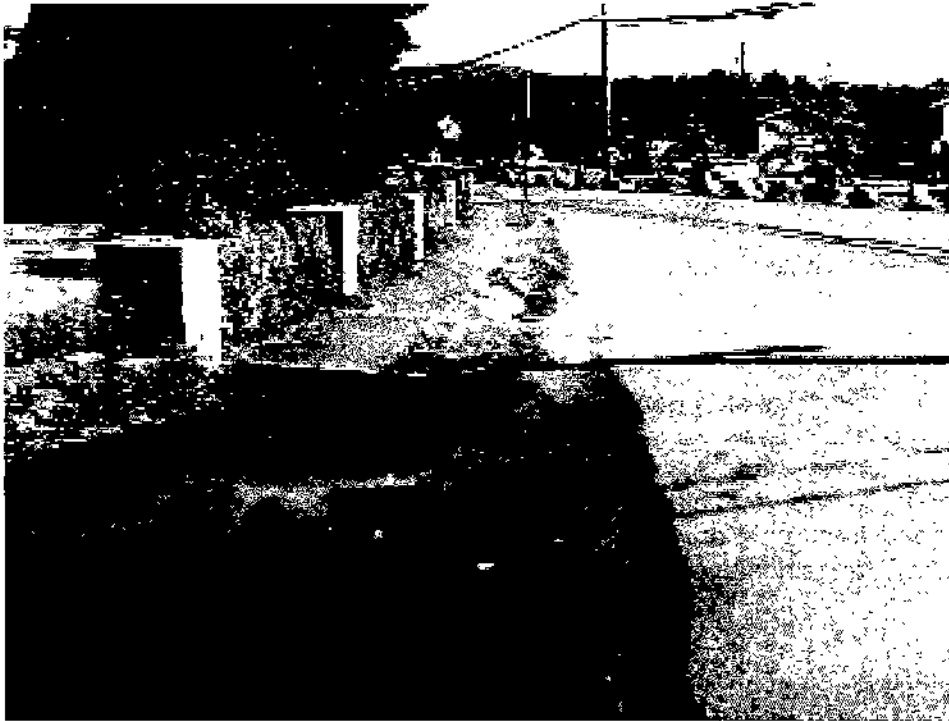
Looking North across the alley entrance and along the West edge of West Ave.

The flow from the road frontage along West Ave is collected in this catch basin. The flow from this catch basin flows to the existing catch basin to the south near the Division Street intersection. This system continues to flow southwest to the main trunkline in the center of Division Street. This system discharges untreated stormwater into the Stillaguamish River. Proposed improvements along West Avenue will discharge to this system. Credit will be taken for areas within Division Street to mitigate flows to this system. See Offsite narrative under the following Section.
