**Revised Drainage Report
For the Oso Lumber
Future Development Site
Arlington, Washington**

Prepared by:
John W. Cherry, P.E.

February 26, 2007

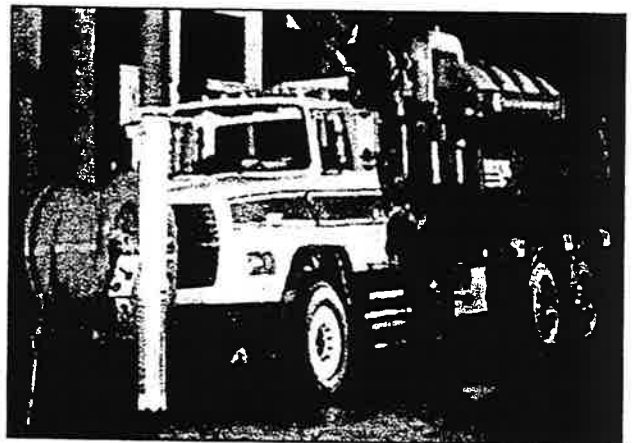
A typical JetVac truck. (This is not a StormTech product.)

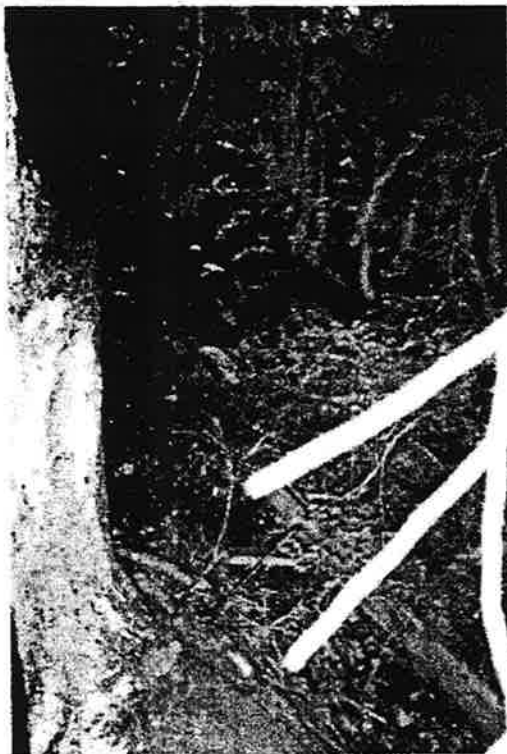
Storm water outfall between Lots 234 and
236 Jensen

A 12-inch storm water pipe that receives water from Jensen Street empties out near the base of the steeper slope between 234 Jensen and 236 Jensen. This pipe appears to be part of the original development and has been in place for tens of years. During our visit it was raining and we observed a significant flow from this pipe. The flow traveled overland down the slope for about 20 feet where it disappeared, being infiltrated into the underlying sand and gravel deposit. We did not observe significant amount of erosion on the slope from this pipe. The photograph below shows this storm water outfall. We did not observe signs of slope movement. The evergreen trees on the slope were fairly mature and did not show signs of past hillside movement. These trees were estimated to be over 40 years old.

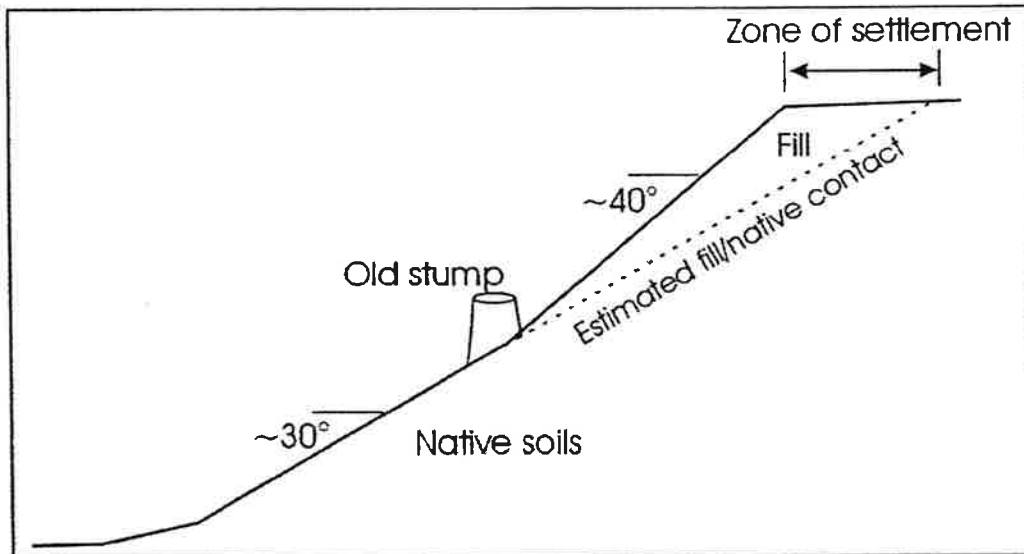
Schematic of fill placed on top of slope:

of the slope. We did not walk the slope entirely in this area. We traversed west of the proposed cut to behind the residence located at 238 West Jensen. We observed a few lots in this area where it was apparent that fill was placed on the top of the slope to increase lot size. Structures were also built on this fill. The steepest portions of the original slope, in this area, was inclined on the order of 30 degrees with some of the fill being at a steeper inclination.

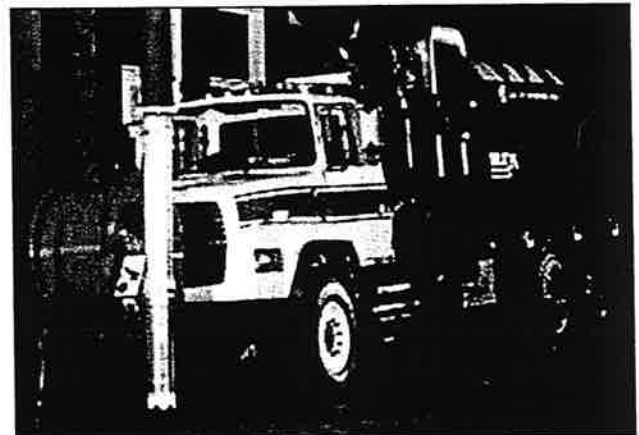
A typical JetVac truck. (This is not a StormTech product.)

JetVac maintenance is required if sediment has been collected to an average depth of 3 inches or more inside the Isolator Row. The JetVac process utilizes a high pressure water nozzle to propel itself down the Isolator Row while scouring and suspending sediments. As the nozzle is retrieved, a wave of suspended sediments is flushed back into the manhole for vacuuming. Most sewer and pipe maintenance companies have vacuum/JetVac combination vehicles. Fixed nozzles designed for culverts or large diameter pipe cleaning are preferable. Rear facing jets with an effective spread of at least 45° are best. Most JetVac reels have a minimum of 400 feet of hose allowing maintenance of an Isolator Row up to 50 chambers long. The JetVac process shall only be performed on StormTech Rows that have AASHTO class 1 woven geotextile over their angular base stone.
