**STORM DRAINAGE  
ANALYSIS FOR  
SOLID ROCK CREATIONS**

**67<sup>TH</sup> AVENUE NE  
ARLINGTON, WASHINGTON**

February 26, 2010

## PROJECT DESCRIPTION

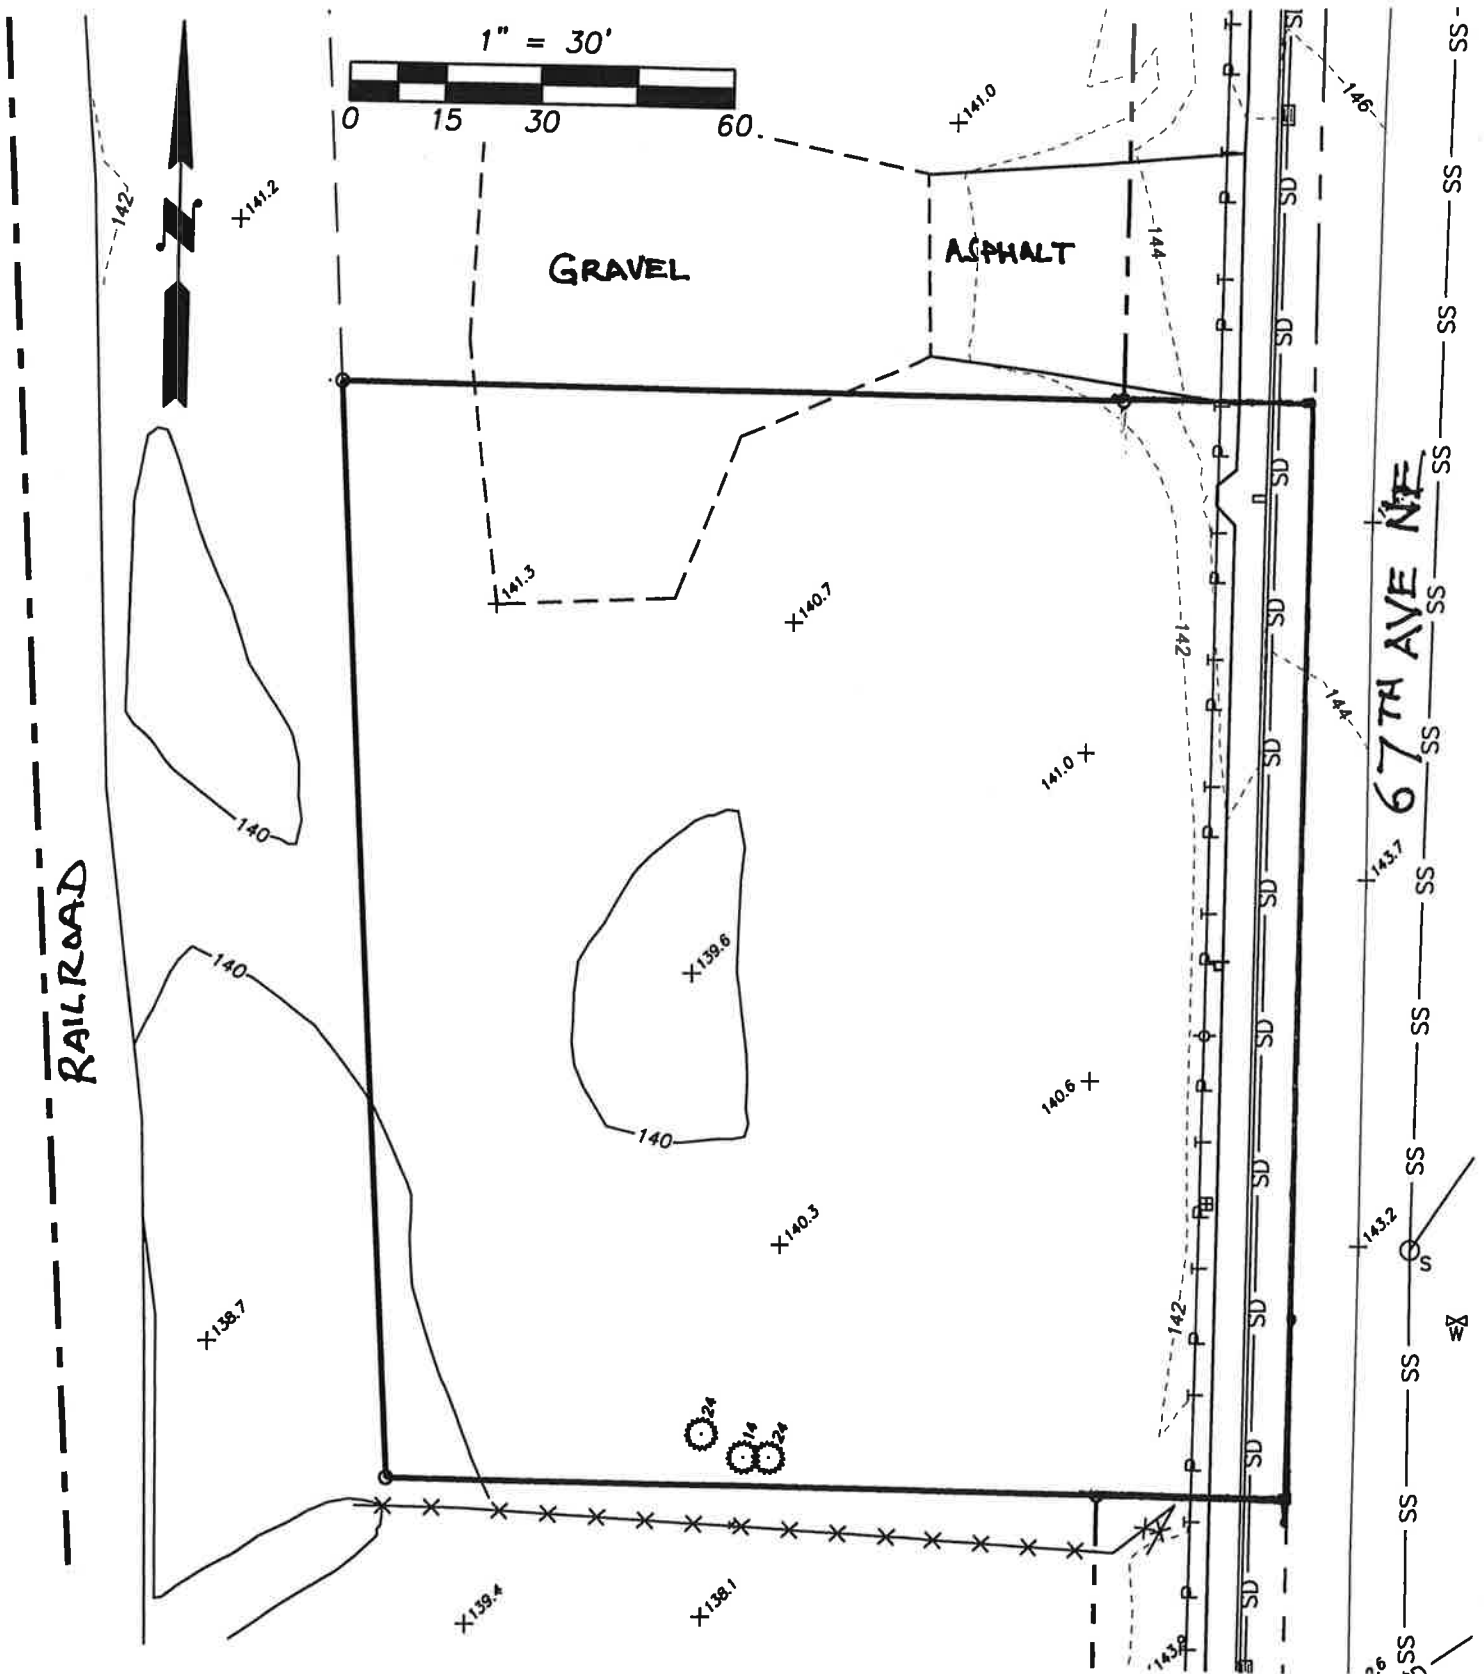
FIGURE 2: EXISTING CONDITIONS

In the near distant past, the site had a single family residence with a drainfield. The house has been demolished and the drainfield decommissioned, so the site is currently vacant. The frontage along 67<sup>th</sup> Avenue NE is fully built out with curb, gutter and sidewalk. To the west lie the railroad tracks. To the north is City owned property that is currently a gravel driveway with access to the site. To the south lies a storm drainage pond. Storm, sewer and water utilities are located in the street. The site falls quickly from the roadway and then is flat at elevations ranging from 140 at the southwest corner to 141 at the northeast corner. There are no wetlands or other critical areas on or near the site. See Figure 2: Existing Conditions.

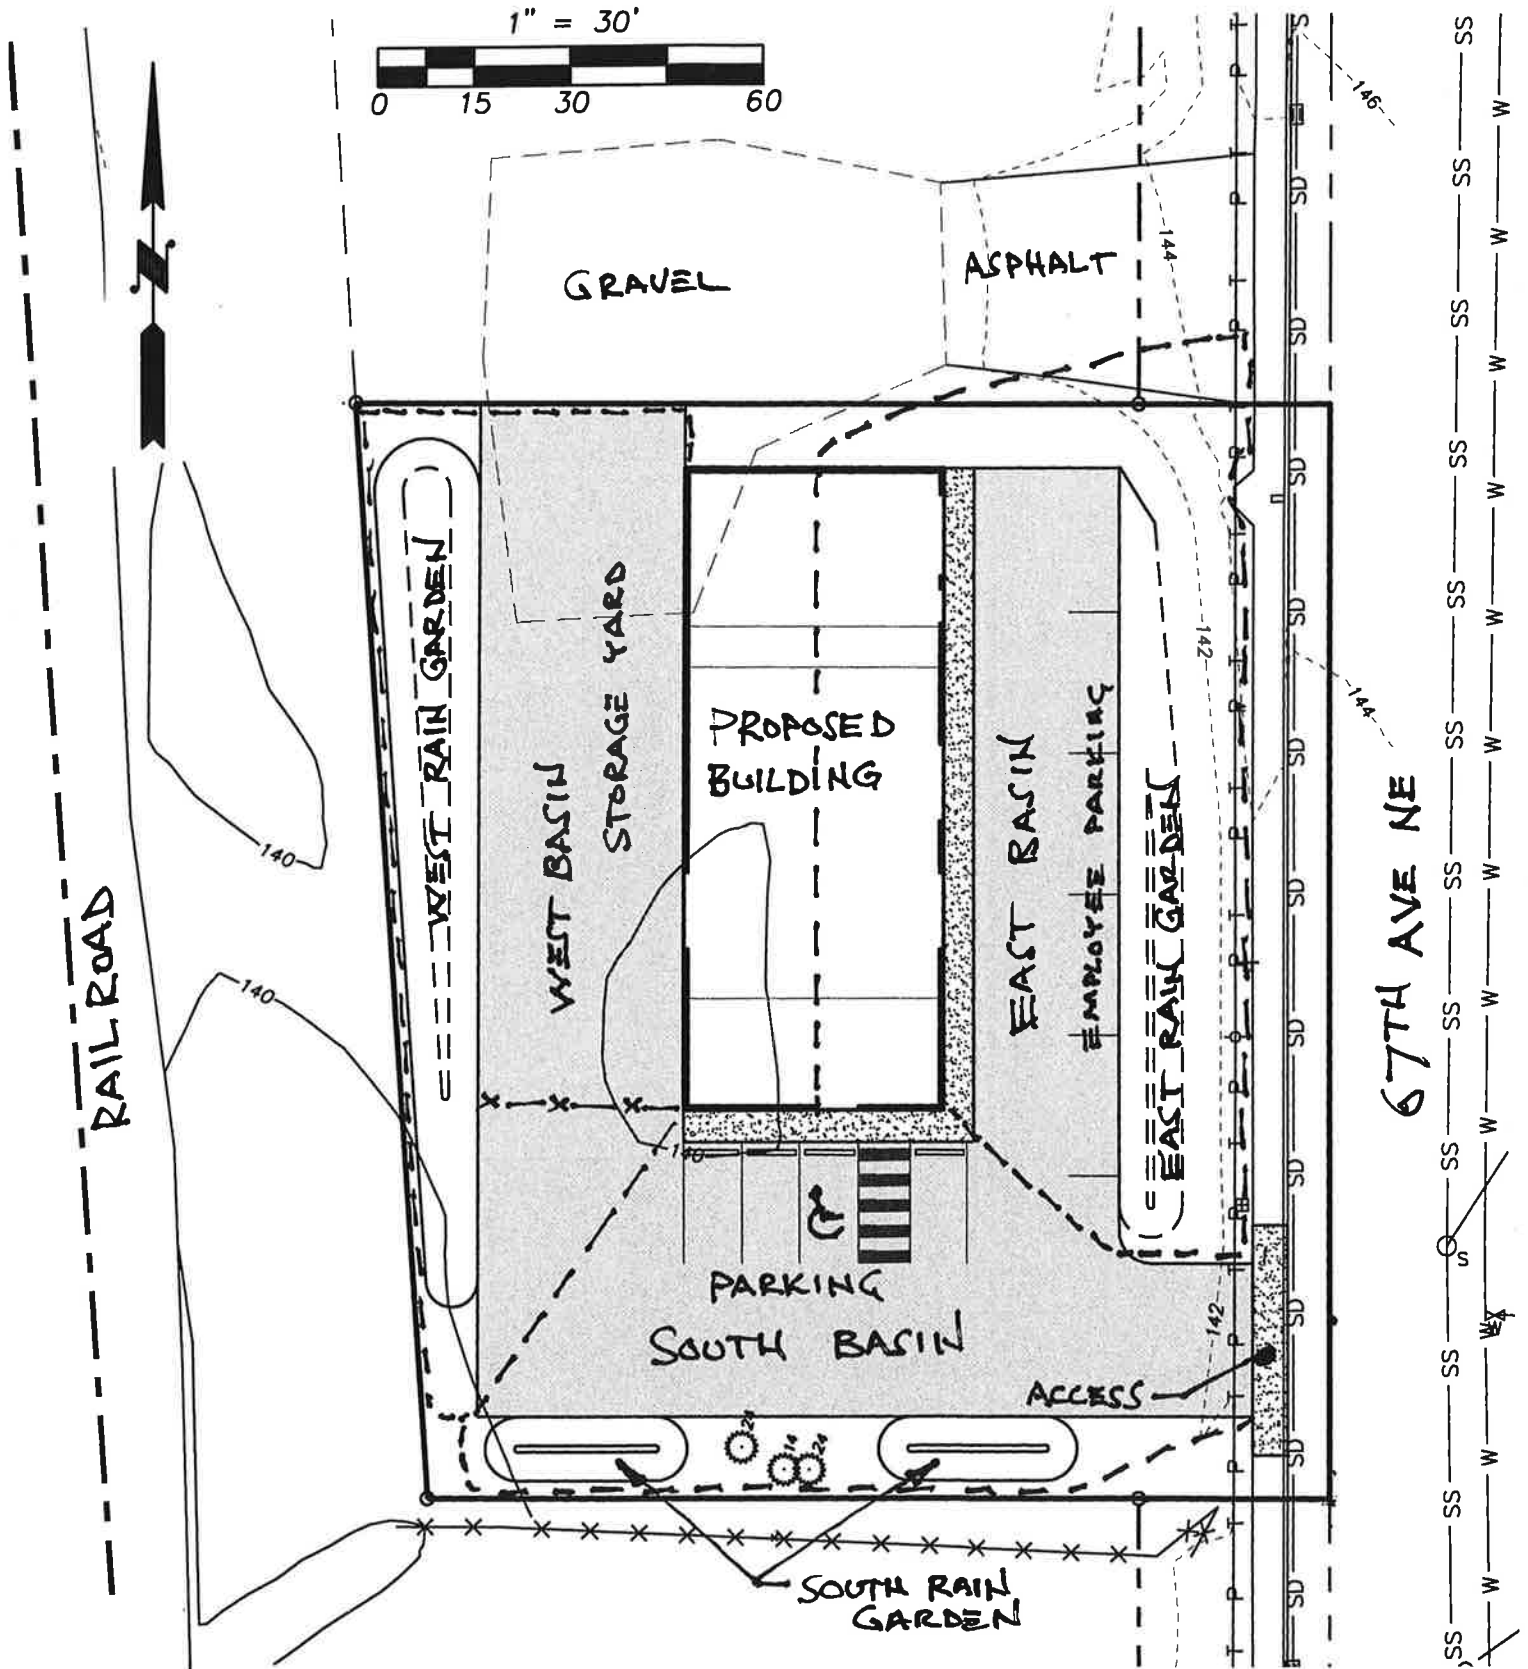
FIGURE 3: DEVELOPED SITE

The planned site development is to construct a 4,020 sf building that will serve Solid Rock Creations as a showroom and production site. See Figure 3: Developed Site. The building sits near the middle of the north property line with parking to the south, building access and parking to the east and a paved storage yard to the west. The main access is from 67<sup>th</sup> Avenue NE at the southeast corner. The storage yard has access to the gravel drive on the City property.

The proposed drainage system consists of collection and conveyance of the runoff from the building and pavement by catch basins and underground pipe. Storm water from surfaces subject to regular vehicular traffic will be treated using a bio-retention cell (rain garden); see Minimum Requirement #6 below. An infiltration trench is the proposed flow control measure; see Minimum Requirement #7 below.

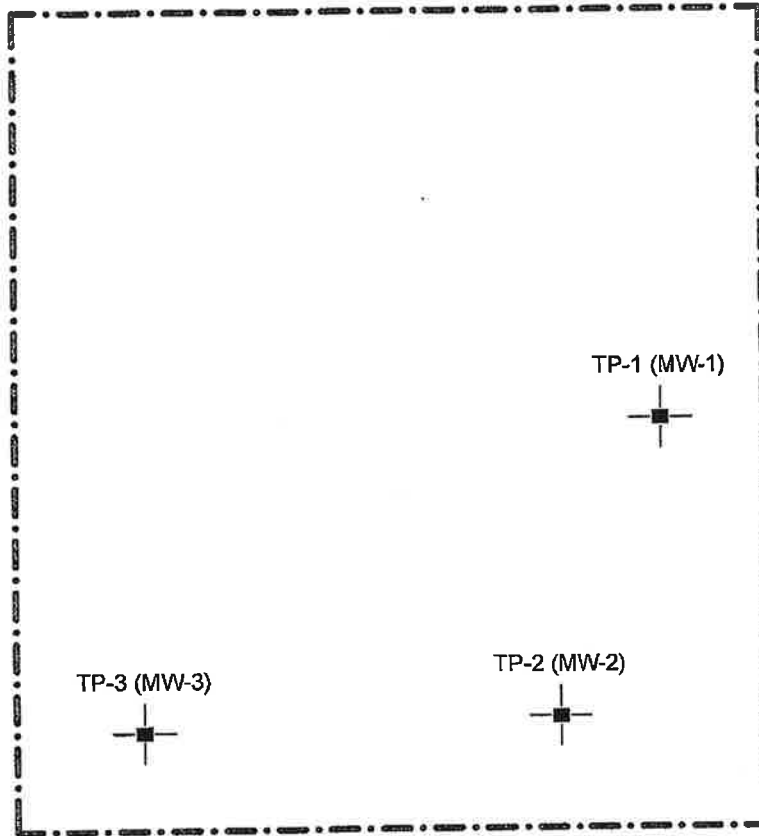
Northern Pacific Railroad

67th Ave NE

\*Note: Infiltration system should be a minimum of 50 feet from pond slopes.

Final development plans were not available at the time this letter was prepared; however you informed us that planned improvements would consist of a building in the northern portion of the site, and parking on the eastern and southern portions of the site. You desire to infiltrate stormwater generated on site. An infiltration system would be placed under the parking areas. A general schematic site layout is shown on the Site Plan in Figure 2.

**Explorations:** The subsurface conditions within the site were explored on January 15, 2010 by excavating three test pits with a mini-trackhoe. Water monitoring pipes were also installed in all of the explorations. The approximate locations of our explorations are shown on the Schematic Site Plan in Figure 2. A geologist from Nelson Geotechnical Associates, Inc. (NGA) was present during the explorations, collected samples of the soils encountered, and maintained logs of the explorations. The soils were visually classified in general accordance with the Unified Soil Classification System, presented as Figure 3. The logs of the explorations are presented as Figure 4.

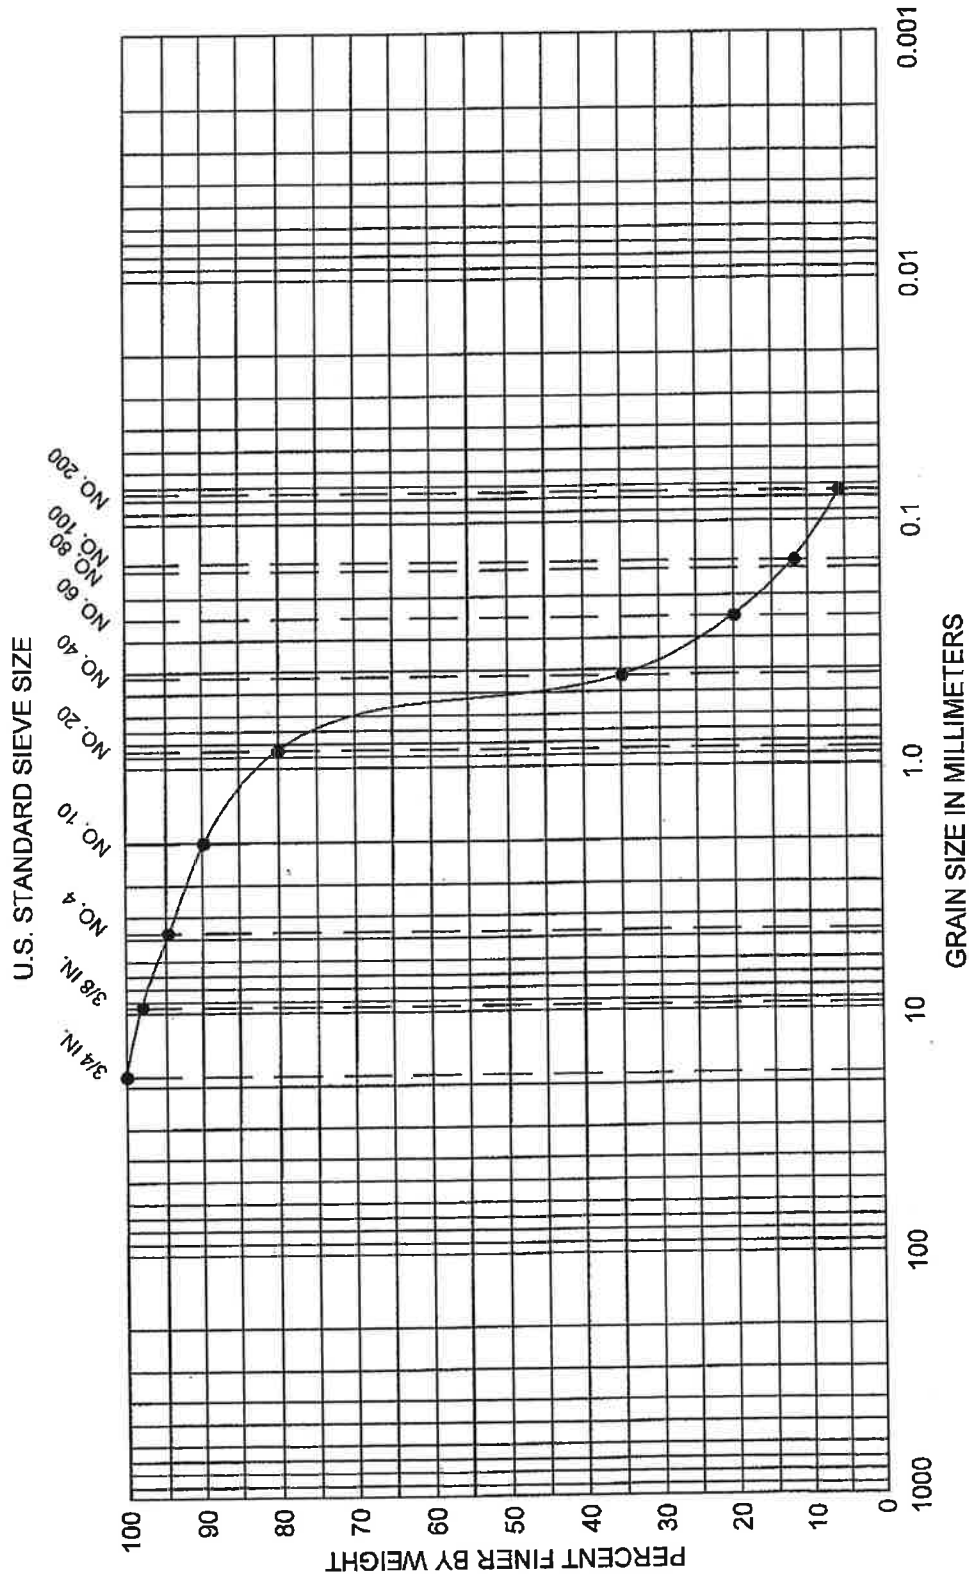
COBBLES	GRAVEL		SAND			SILT OR CLAY
	COARSE	FINE	COARSE	MEDIUM	FINE

U.S.C. SYMBOL	EXPLORATION NUMBER	SAMPLE DEPTH	SOIL DESCRIPTION	SOIL DISTRIBUTION
● SP-SM	TP-1	5.5 feet	Light brown-gray, fine to medium sand with silt	Gravel = 5% Sand = 89% Silt/Clay = 6%

U.S. STANDARD SIEVE SIZE

3/4 IN. NO. 4  
3/8 IN. NO. 10  
NO. 20  
NO. 40  
NO. 60  
NO. 80  
NO. 100  
NO. 200

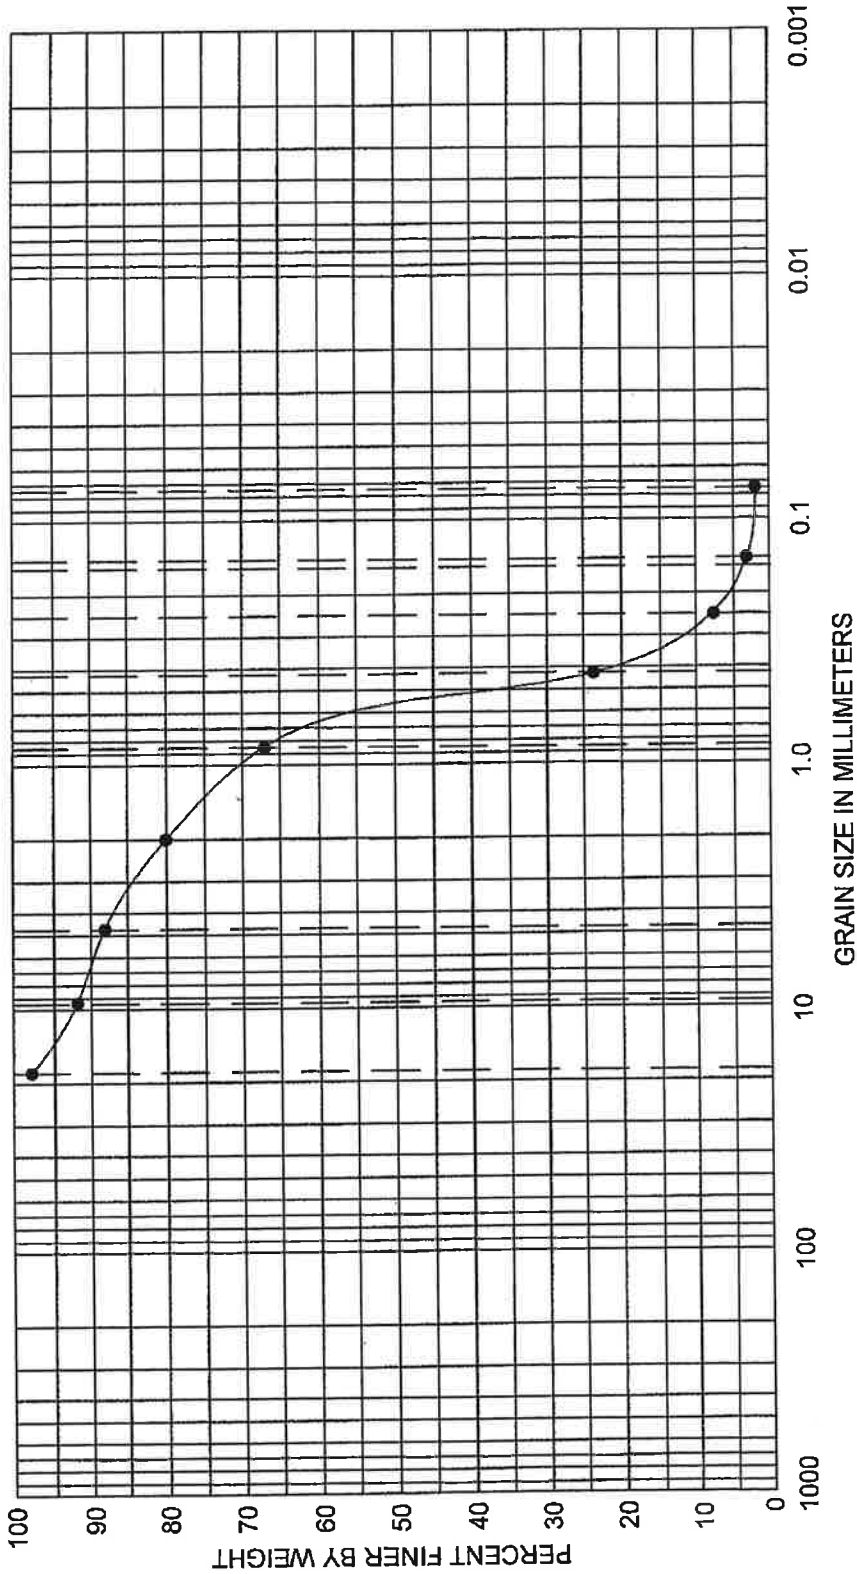
COBBLES	GRAVEL		SAND			SILT OR CLAY
	COARSE	FINE	COARSE	MEDIUM	FINE

U.S.C. SYMBOL	EXPLORATION NUMBER	SAMPLE DEPTH	SOIL DESCRIPTION	SOIL DISTRIBUTION
●SP	TP-2	4.0 feet	Light brown-gray, fine to medium sand with trace silt and gravel	Gravel = 12% Sand = 86% Silt/Clay = 2%

U.S. STANDARD SIEVE SIZE

3/4 IN.  
3/8 IN.  
NO. 4  
NO. 10  
NO. 20  
NO. 40  
NO. 60  
NO. 80  
NO. 100  
NO. 200

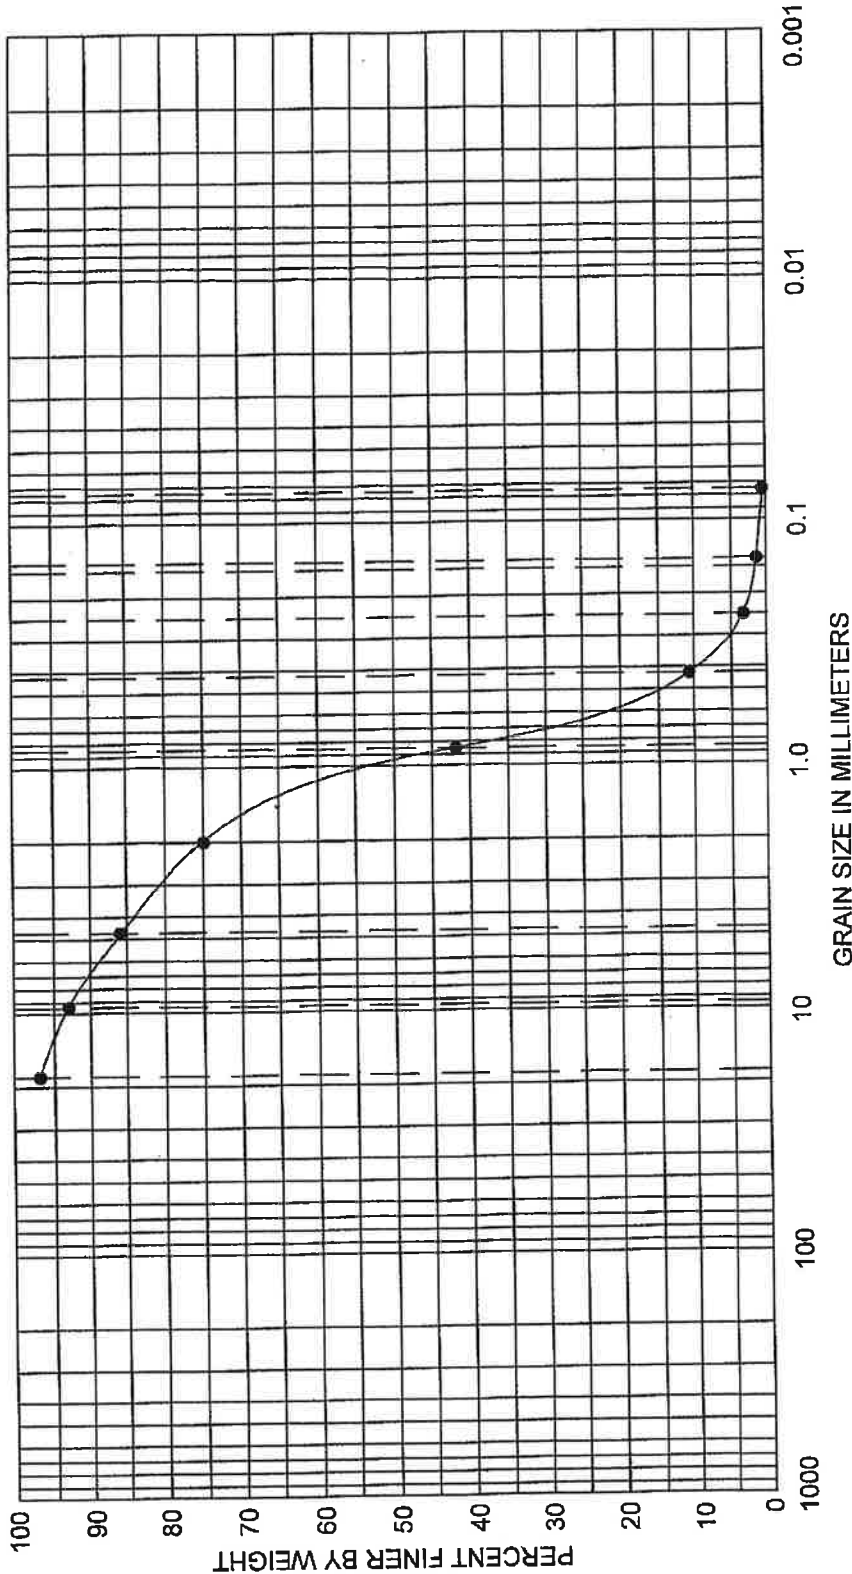
COBBLES	GRAVEL		SAND			SILT OR CLAY
	COARSE	FINE	COARSE	MEDIUM	FINE

U.S.C. SYMBOL	EXPLORATION NUMBER	SAMPLE DEPTH	SOIL DESCRIPTION	SOIL DISTRIBUTION
●SP	TP-3	6.0 feet	Light brown-gray, fine to medium sand with trace gravel	Gravel = 14% Sand = 86% Silt/Clay = 0%
