Stormwater Management Report

Village Community Services Parking Lot Resurfacing Phase 1 & 2

TerraVista NW LLC
Consulting Engineers

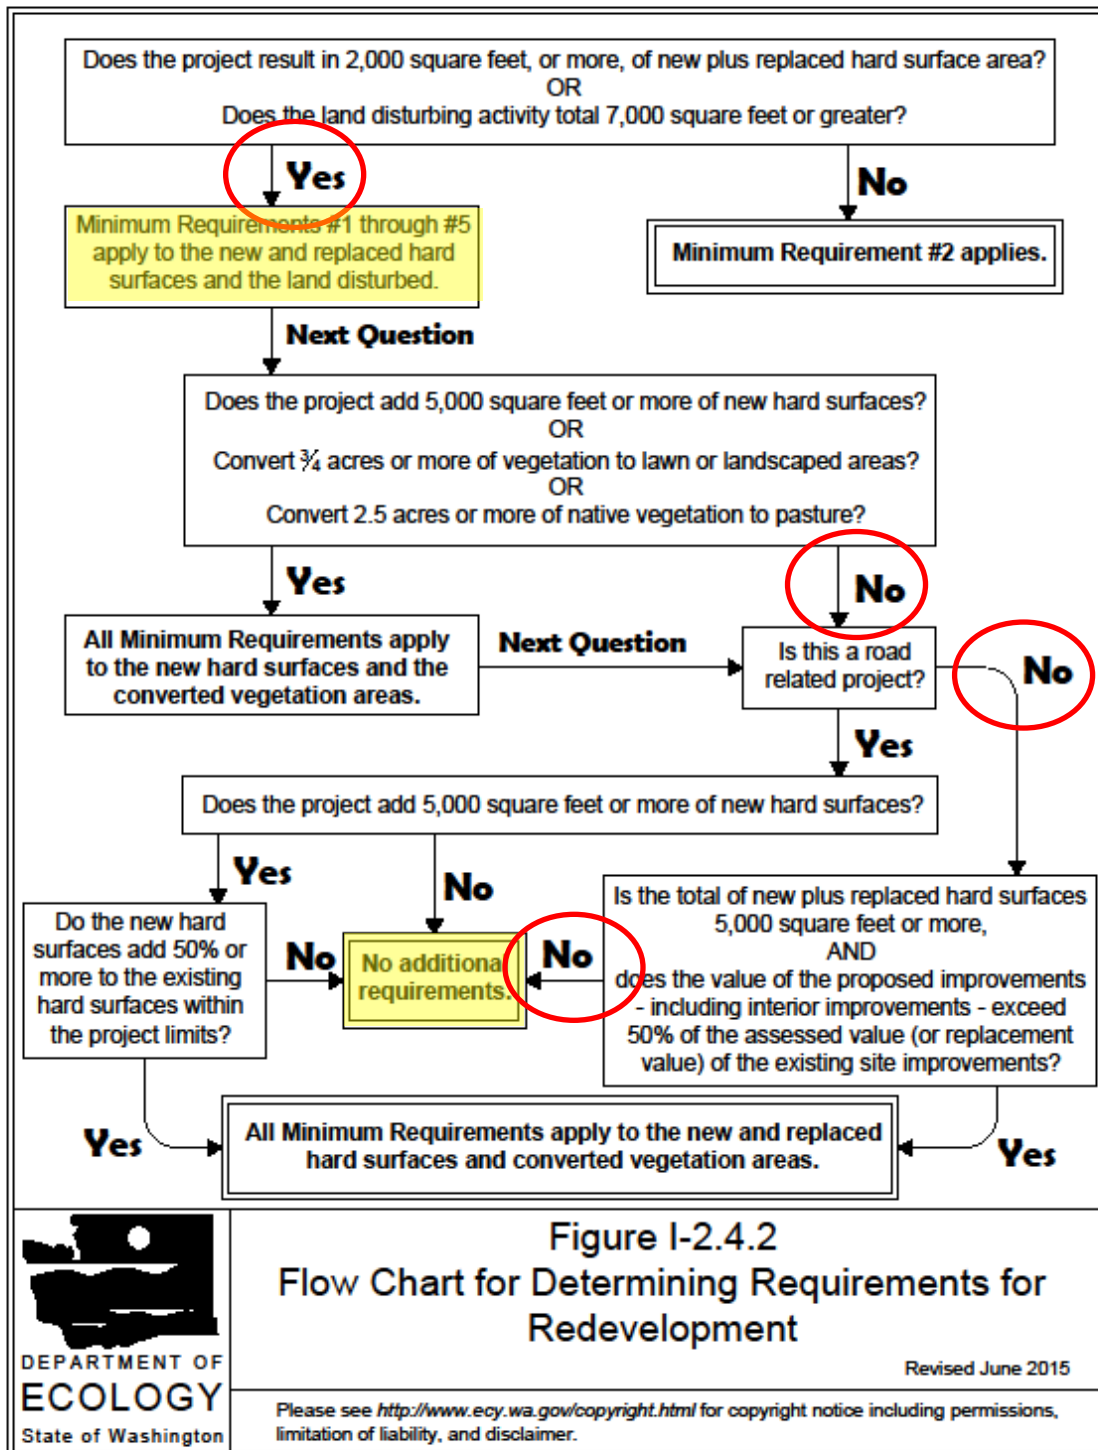
Minimum requirements 1-5 shall apply to the project.

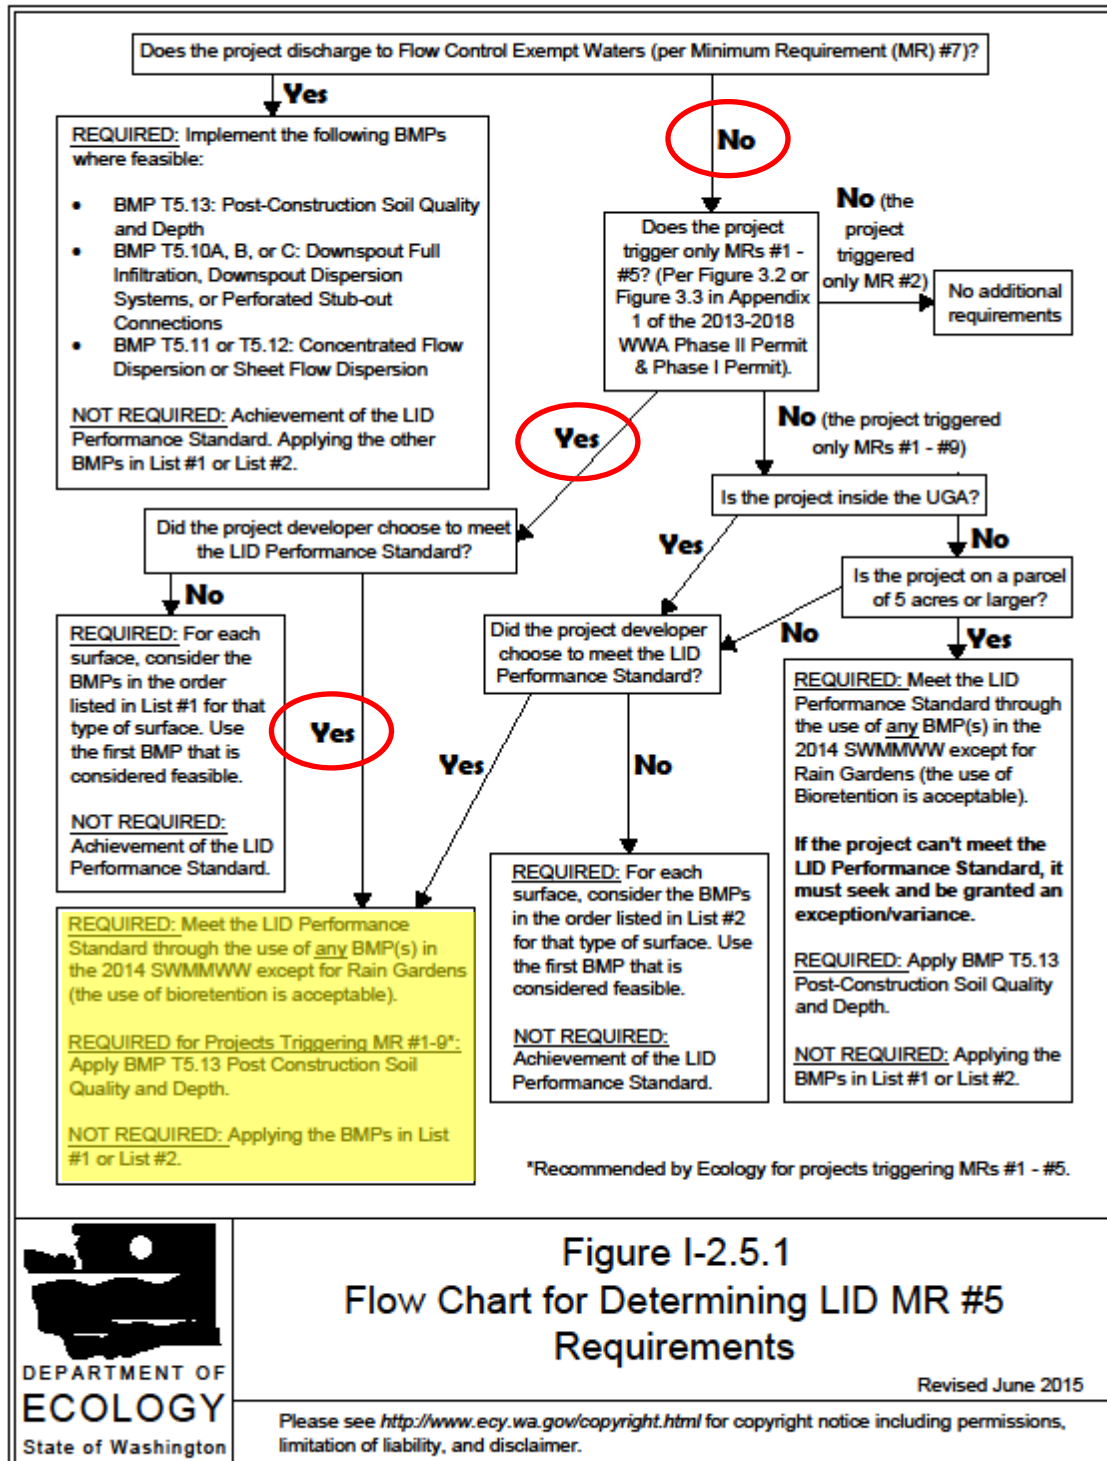
The project will infiltrate 100% of the stormwater, therefore the LID standard is being met. The Phase 1 Parking Lot will drain to the existing infiltration system, which infiltrates 100% of the stormwater. Due to the failure of the existing storm drain system for the Phase 2 lot, Phase 2 will utilize a newly constructed infiltration system with the following parameters.
