STORMWATER SITE PLAN REPORT
CASCADE DOOR & HARDWARE BUILDING
199TH AVENUE N.E.
ARLINGTON, WASHINGTON
LOT 4, AIRPORT-37 INDUSTRIAL PARK
CITY OF ARLINGTON FILE # _____

BENNETT ENGR. PROJECT #07039

The proposed site development is presented in the attached civil engineering drawing set (Sheets C-1 through C-5, Section 10) prepared by Bennett Engineering, LLC. The types of water quality BMPs proposed for the project include:

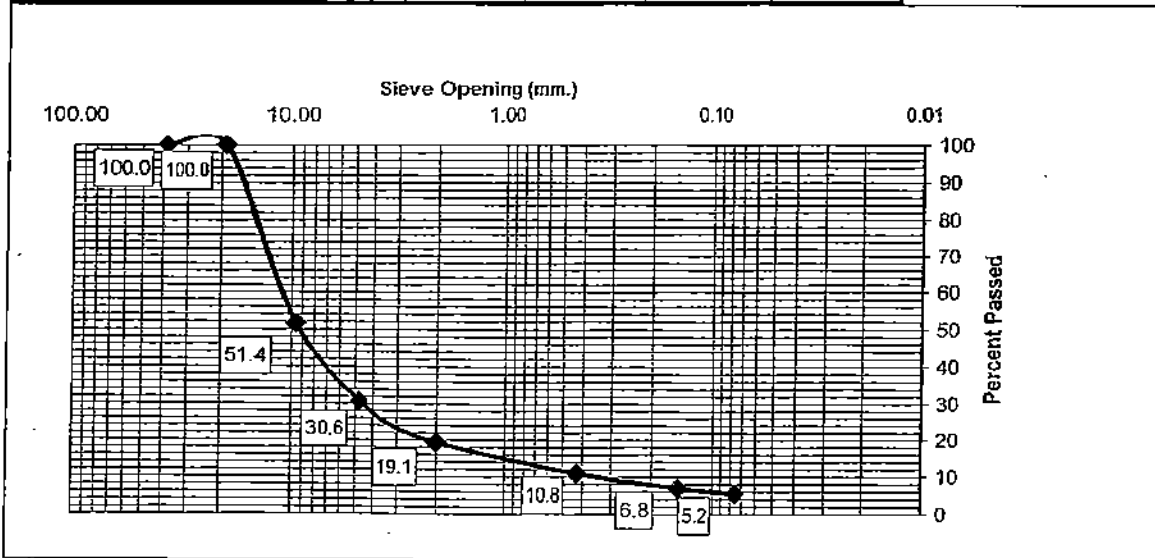
Washed Soil Weight: 37.7 grams

Sieve US Inches or No.	Sieve Size (mm)	Weight Retained (grams)		Percent Retained		Percent Passed
		Each	Total	Each	Total	
1 1/2	38.10	0.0	0.0	0.0	0.0	100.0
3/4	19.05	0.0	0.0	0.0	0.0	100.0
3/8	9.53	303.6	303.6	48.6	48.6	51.4
4	4.75	130.2	433.8	20.8	69.4	30.6
10	2.00	71.5	505.3	11.4	80.9	19.1
40	0.43	52.4	557.7	8.4	89.2	10.8
100	0.15	24.9	582.6	4.0	93.2	6.8
200	0.08	9.5	592.1	1.5	94.8	5.2
<200	0.00	2.0	594.1	0.3	95.1	4.9
Total			634.8		100.0

Laboratory grain-size analyses were conducted on soil samples from TP-1 and TP-3 to confirm classification of the native soils and determine the applicable stormwater infiltration rate for the site. The laboratory data is presented in Section 7. The TP-1 sample was taken at 2.5 feet bgs and consisted of a clean, well graded sand with some gravel. The TP-1 sample had a D₁₀ size of 0.25 mm, which, based on review of the soil logs, appears to be representative of the native sand and gravel soils encountered at the site. The TP-3 sample was taken from a sandy gravel layer encountered between 5.0 and 7.0 feet bgs, with a D₁₀ size of 0.36 mm. The sandy gravel layer was not observed in any of the other test pits. Based on a typical D₁₀ size of 0.25 mm, an infiltration rate of 3.5 inches/hour was selected for the project design (see attached Table 3.8 from Volume III of the 2005 DOE Manual, Section 7).
