**CONSTRUCTION DRAINAGE REPORT  
FOR  
MACLEOD APARTMENTS**

**CITY OF ARLINGTON**

**MAC ENGINEERING, LLC**

Prepared by: Elden D. McCall, P.E.  
Date: December 17<sup>th</sup>, 2008  
Project Number: 080003

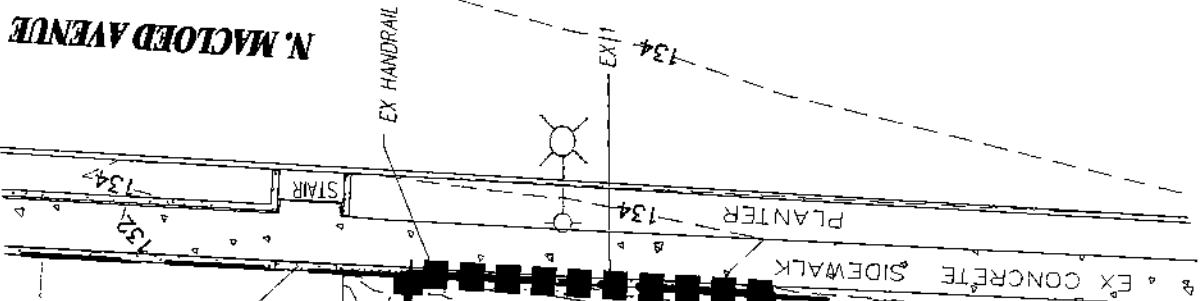
# MACLEOD APARTMENTS DEVELOPED CONDITIONS BASIN MAP EXHIBIT

N. MACLEOD AVENUE

APARTMENT / LAW OFFICE

STEP TO BUILDING

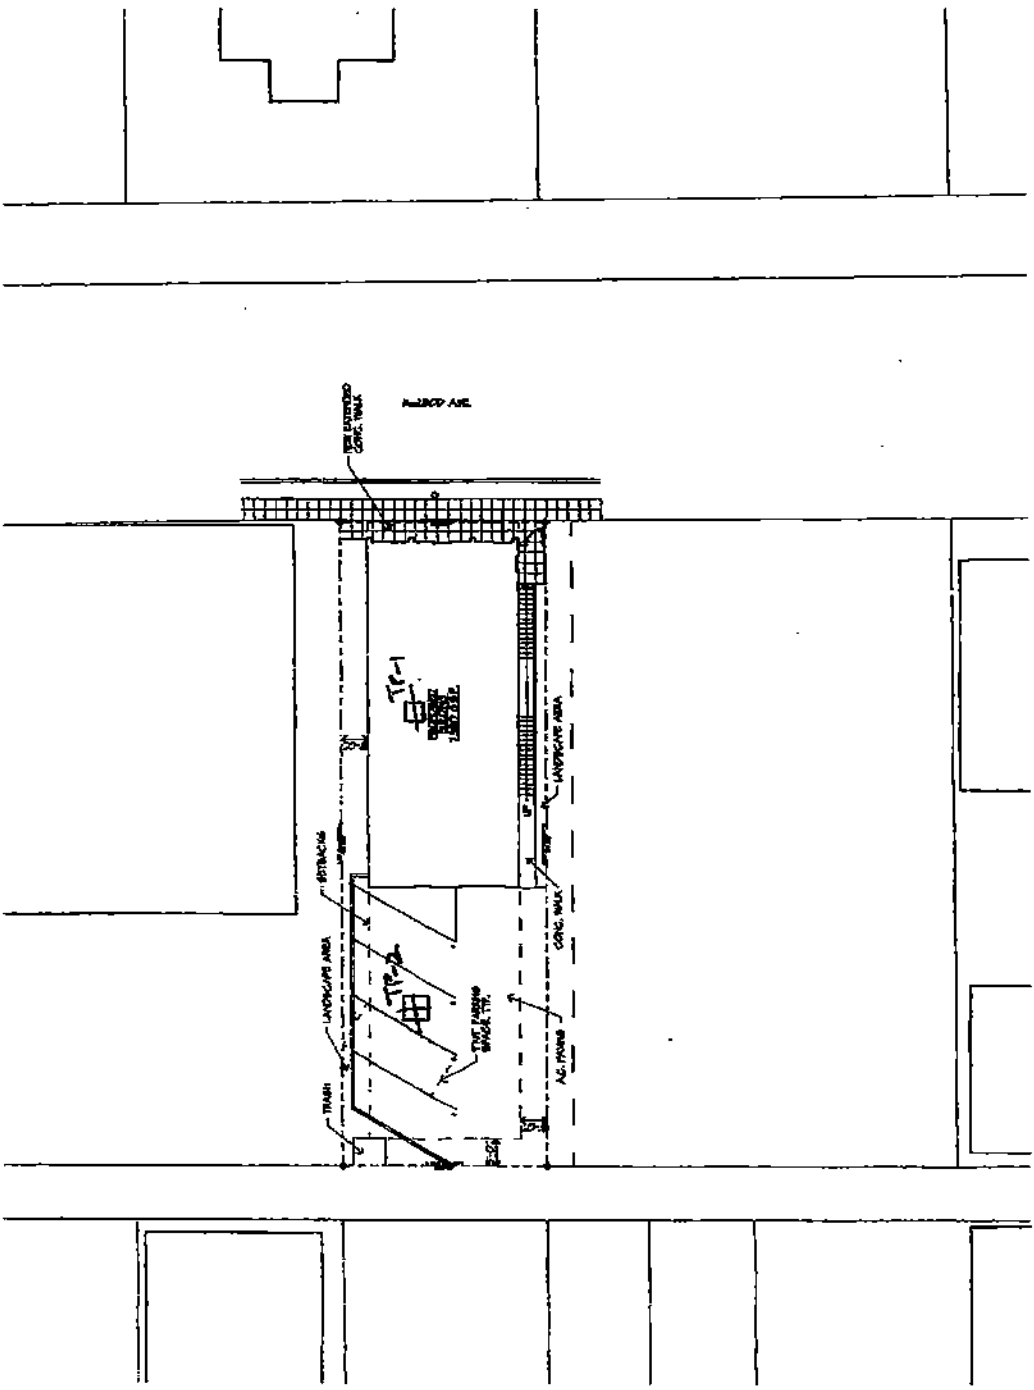
# Site Plan

TP-1
