City of Arlington Preliminary Site Assessment

Parcel Number:	00529901101000
Parcel Area (acres):	0
Site Address:	319 5TH ST
Property Owner:	MCDONALD DAVID E & MARY E LIVING TRUST

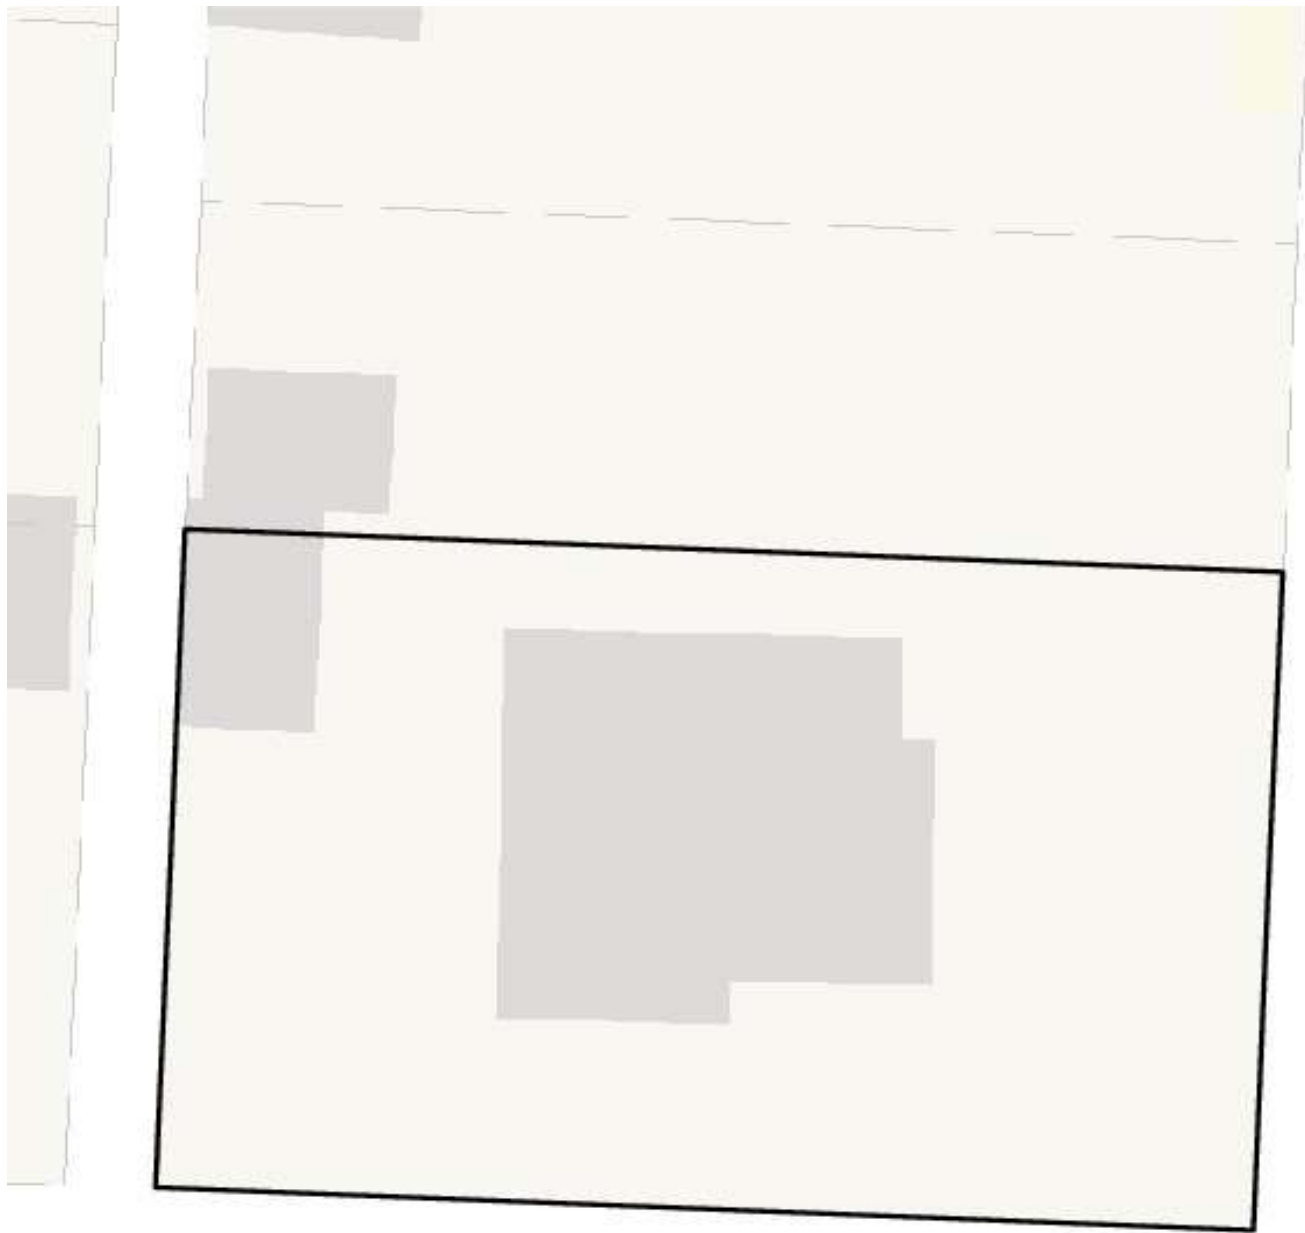
CRITICAL AREAS MAP

Percent Saturated/Wetland Soils Onsite			USGS Aquifer Sensitivity	Low:	
Slopes Onsite	0 to 8%	93.4%		Medium:	100.0%
	8 to 12%	5.7%		High:	
	12 to 15%	0.9%	Drinking Water Well Onsite?		No
	15 to 20%		Soil Contamination Area Onsite?		No
	20 to 33%		UST Onsite?		No
> 33%		Septic System Onsite?		No

PERCENT OF SITE POTENTIALLY NOT SUITABLE FOR BMP IMPLEMENTATION

Infiltrating Bioretention Cell/Swale	7%	Permeable Pavement	1%	Underground Detention and Treatment	On a site by site basis
Infiltrating Bioretention Planter	7%	Ponds and Wetlands	On a site by site basis	Aboveground Sand Filtration	On a site by site basis
Non-Infiltrating Bioretention	7%	Basic Filter Strips	On a site by site basis	Infiltration BMPs	On a site by site basis
		Biofiltration Swales	On a site by site basis	Dispersion BMPs	On a site by site basis
